# GRANDE PRAIRIE FACILITIES ANALYSIS REPORT

# Facilities Analysis Report

**Hythe Arena**

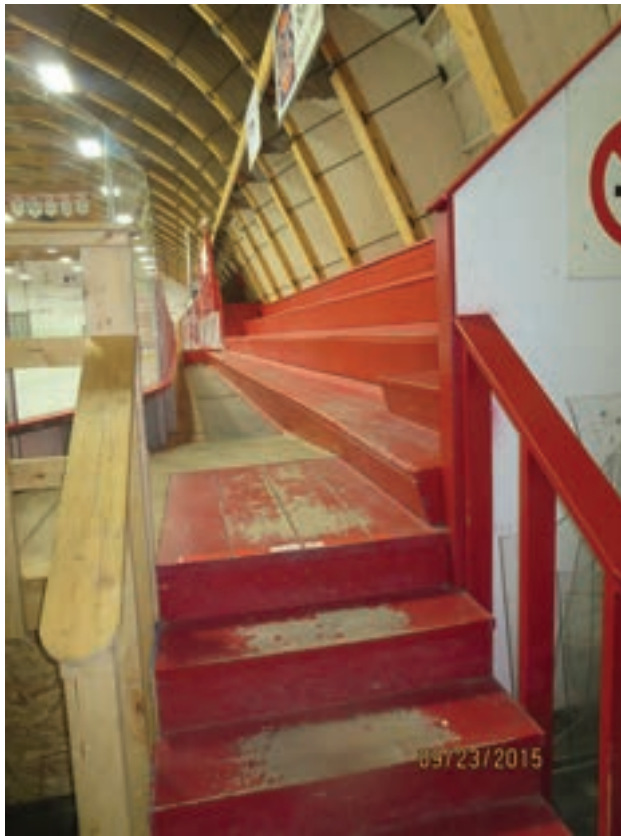
FIG #3.53

The seating areas of the Arena are generally acceptable. Seating is painted wood bleachers and appears to have acceptable exiting. Public access to the seating area is not barrier free. Some repainting of the seating, primarily the high traffic floor areas is required. (See Figure #3.53).

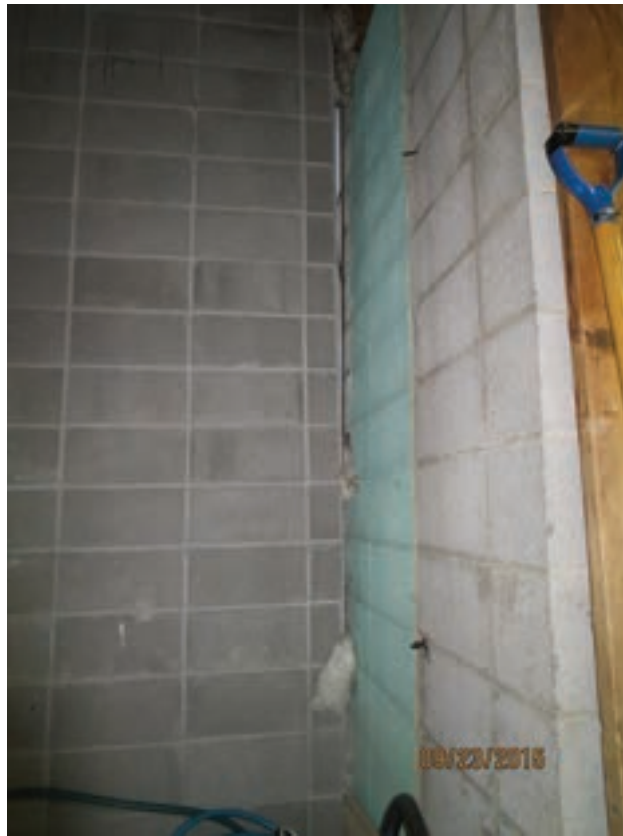
FIG #3.55

The Ice Resurfacers room is generally in acceptable condition and walls are non-combustible concrete block, however there are some conditions that don't provide a fire rated wall as required by code. Specifically the wall gap into the Arena area. (See Figure #3.55). Wall gaps and discontinuities in the fire rated walls should be addressed.

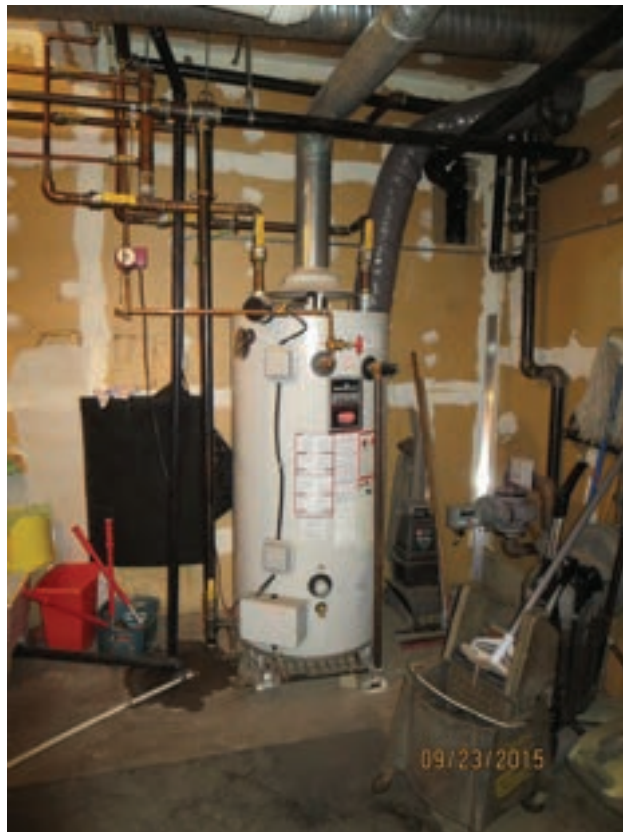
FIG #3.56

A detailed engineering analysis of the existing mechanical infrastructure was not conducted; however there was evidence, or maintenance staff knowledge of furnace upgrades or replacement, hot water tank replacement and fixture and equipment upgrades throughout the building. (See Figures #3.56 and #3.57).

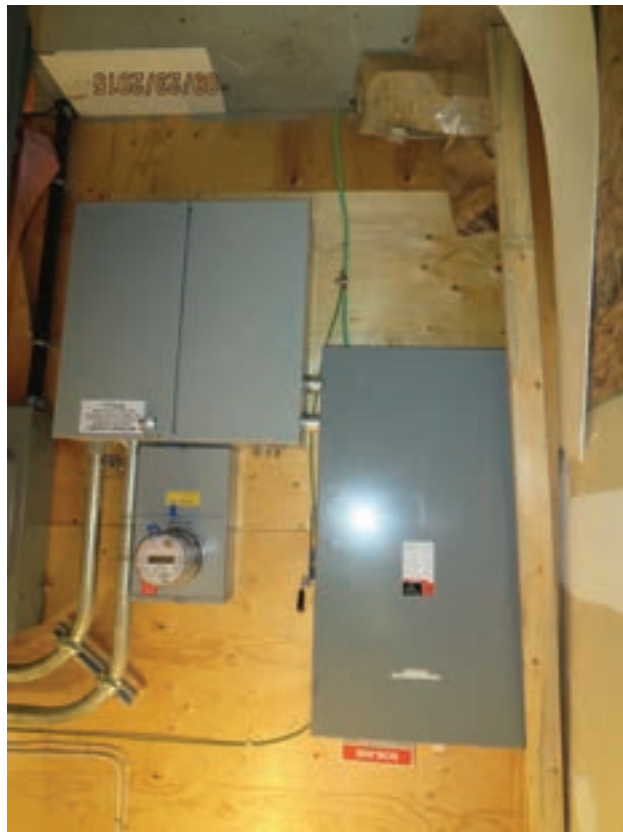
FIG #3.58

A detailed engineering analysis of the existing electrical infrastructure was not conducted. There is an existing 3-phase service to the building which is aerial pole mounted at the south side of the Arena. The service is aerial to the rear of the Arena building. Interior electrical equipment is both original and in some cases upgraded equipment. (See Figures #3.58, #3.59 and #3.60).

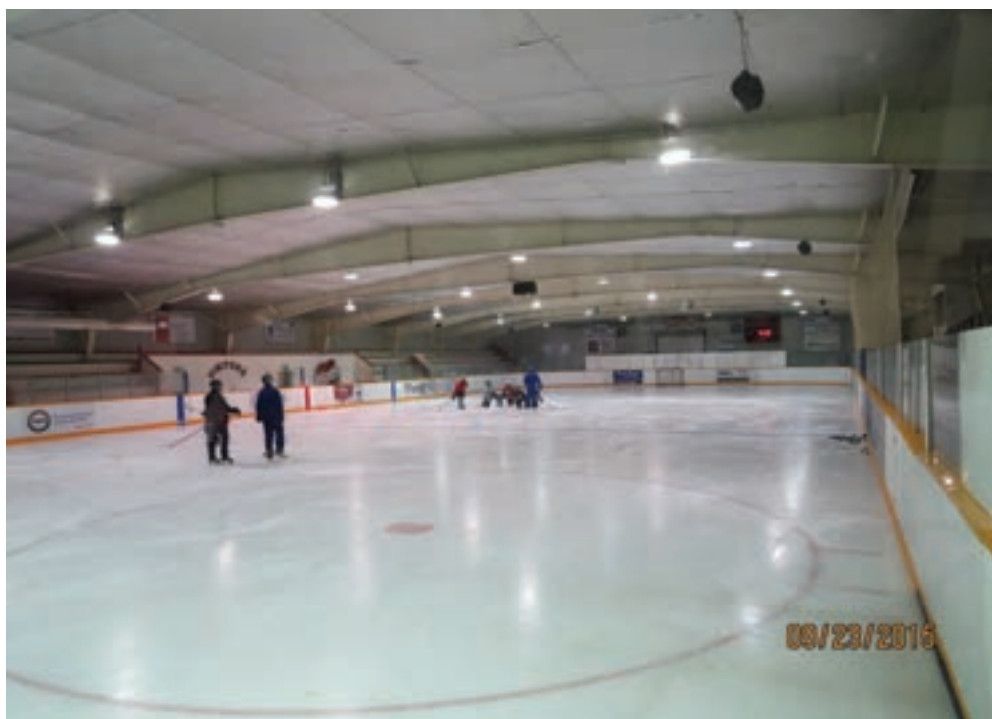
FIG #4.1

The Arena has a pre-engineered steel frame superstructure on concrete receiving foundations; exterior walls and roof are assumed to be framed with standard steel wall and roof purlins. (See Figure #4.1, #4.21 and #4.22). Projected change rooms and Ice Plant room and Ice

The Arena roofs emissivity liner appears to be in acceptable condition, although some puck deflection damage was observed. (See Figure #4.1, #4.21 and #4.40).

Lighting levels in the Main Arena area are somewhat low. Existing lighting technology is older high bay style fixtures (See Figures #4.1 and #4.73). Consideration should be given to either adding more fixtures or re-fixturing the space with 4 or 6 lamp fluorescent technology.

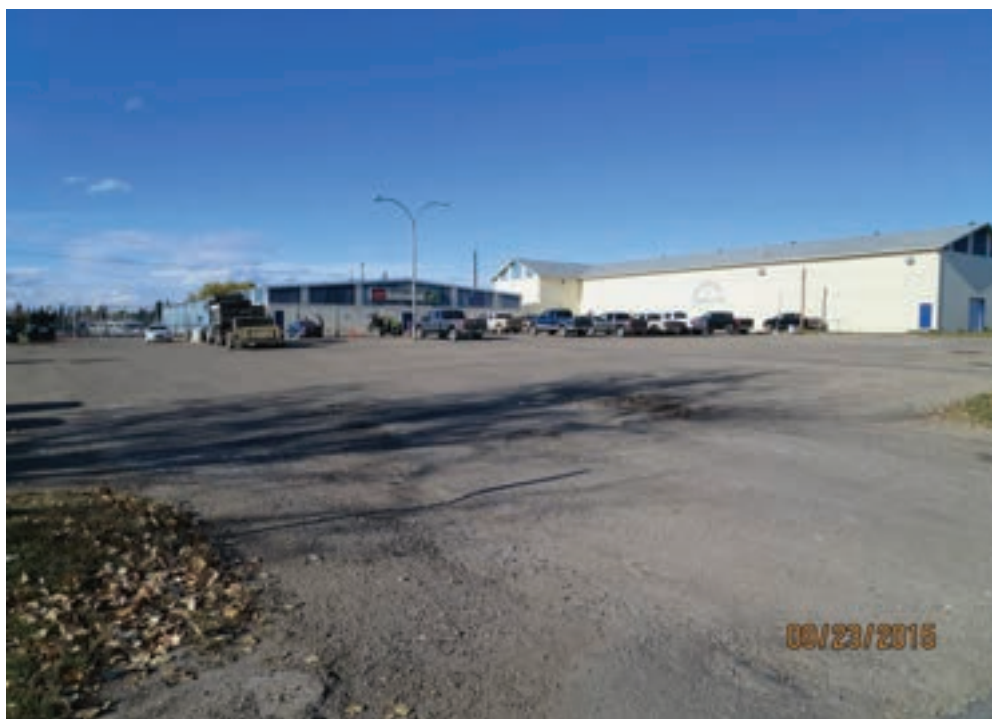
FIG #4.7

The site is generally paved asphalt parking in front, (See Figures #4.7, #4.8, #4.9 and #4.10). Some localized asphalt repair work was being conducted during the review of this facility. Otherwise the asphalt was older, but in acceptable condition. Stall line painting was present in the front parking area and the lot has approximately 130 stalls. Based on information from the building operator the lot is shared with the adjacent school. However, due to differing operating hours of the two buildings, parking count appears to be adequate for day to day Arena operations. At peak demand the lot would not be large enough for the building spectator capacity, but this would be infrequent and adjacent street parking is available.

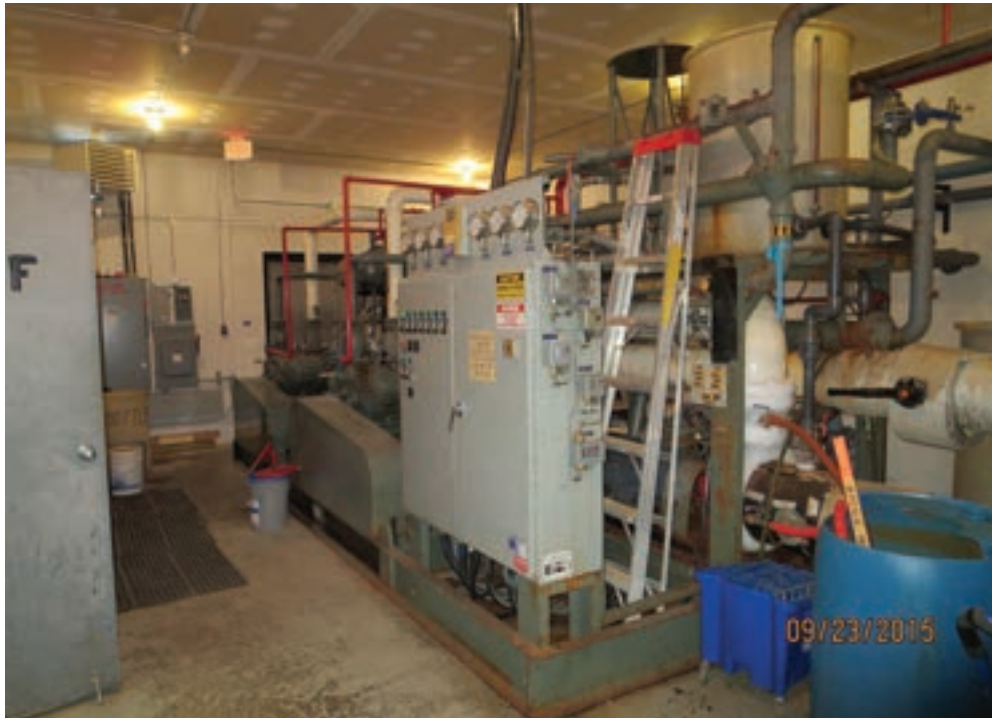
FIG #4.59

The Arena Ice Plant and cooling tower appear to be in good condition. (See Figures #4.59, #4.60, #4.61 and #4.62). The ice plant itself is not new and was relocated from an Edmonton Arena.

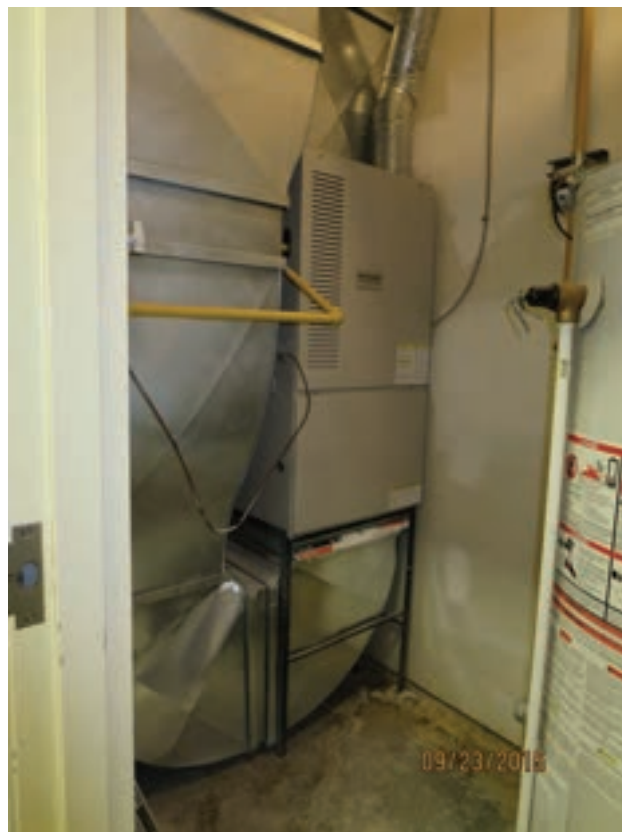
FIG #4.74

A detailed engineering analysis of the existing mechanical infrastructure was not conducted; however there was evidence, or maintenance staff knowledge of equipment replacement, hot water tank replacement and fixture upgrades throughout the building. (See Figures #4.74, #4.75 and #4.76). Duct work is likely original to the building. Generally the mechanical infrastructure appeared acceptable, but ongoing maintenance is required.

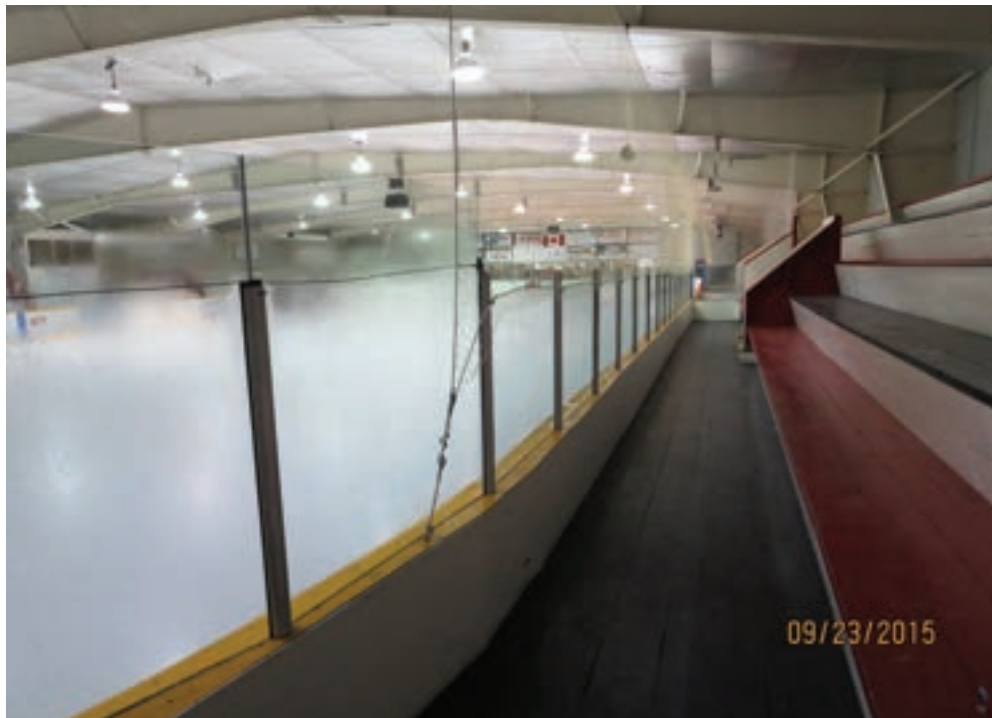
FIG #4.77

Also the Main Arena area is not dehumidified and it causes fogging of the arena and the dasher board glass. (See Figures #4.71, #4.72 and #4.77). Dehumidification unit(s) should be installed.

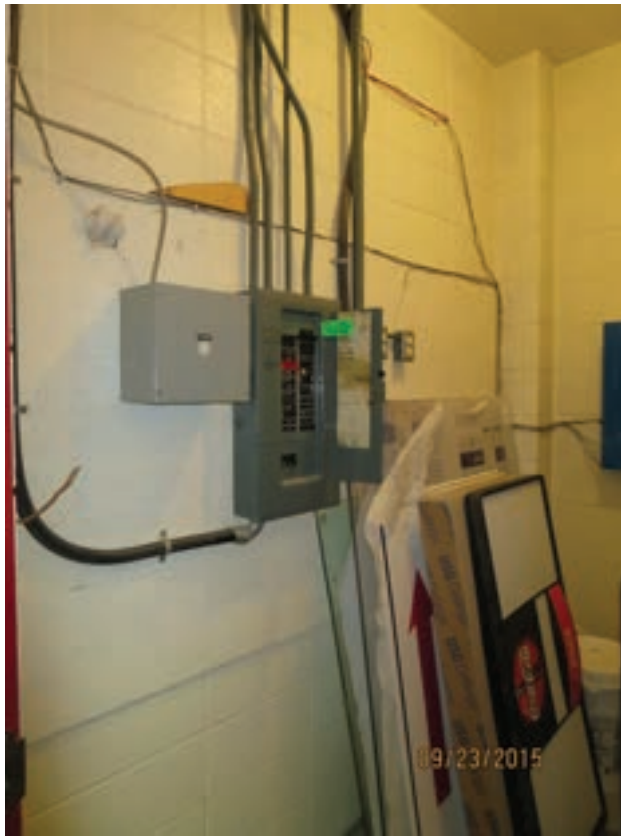
FIG #4.79

A detailed engineering analysis of the existing electrical infrastructure was not conducted. There is an existing 3-phase lateral service down to a grade level transformer near the northeast corner. (See Figure #4.13). Interior electrical equipment is generally original, but the main service was upgraded in the 2008 expansion. (See Figure #4.78). The building house panels generally do not have breaker space available. (See Figures #4.79 and #4.80). The building may require some secondary electrical upgrades in the next five to ten years.

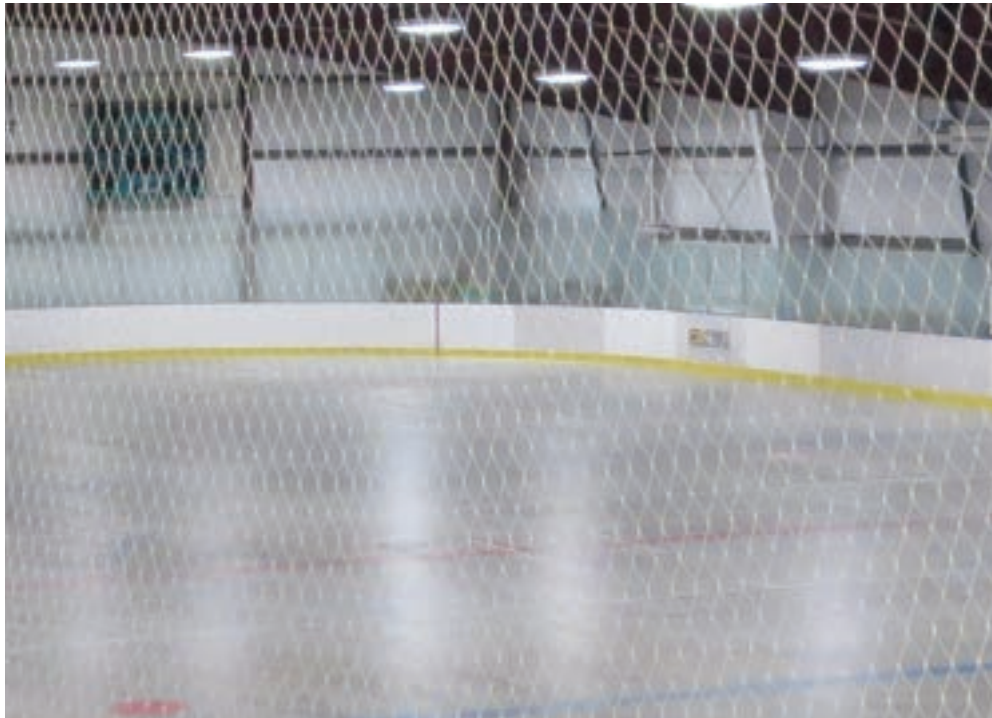
FIG #5.1

The Arena, Arena Lobby and Concession areas have a typical tapering column pre-engineered steel frame superstructure on concrete receiving foundations; exterior walls and roof are framed with standard steel wall and roof purlins. (See Figures #5.1, #5.2, #5.6, #5.7, #5.8, #5.23, #5.24, #5.25 and #5.26). Projected Front Arena Area and Ice Plant room and Ice Resurfacer room spaces, appear to be load bearing concrete block walls with steel roof structure. (See Figures #5.12, #5.13, #5.14 and #5.22 ). Community Hall area structure is non-tapering steel columns with pre-engineered steel roof beams and assumed standard steel wall and roof purlins. (See Figures #5.4, #5.5, #5.27 and #5.28). The building is not sprinklered.

The upper floor Fitness Area, which is accessed through the Arena (See Figures #5.1 and #5.25), has relatively new finishes and they are in acceptable condition. (See Figures #5.72, #5.73, #5.74, #5.75 and #5.76). There are some indications of structural movement of the concrete block walls in this area and this should be monitored. (See Figures #5.77 and #5.78). Washrooms (See Figure #5.79 and #5.80) and Bonus Office Space (See Figure #5.81), both contained on the upper floor level adjacent to the Fitness Area are newly finished and in acceptable condition.

Lighting levels in the Main Arena area are good and the lighting technology is fairly current. (See Figures #5.1 and #5.23). However the main pre-engineered beams in this area are primed steel members only. (See Figures #5.1 and #5.23). Consideration should be given to painting the steel beams white to improve light reflectivity and cleaning of structure.

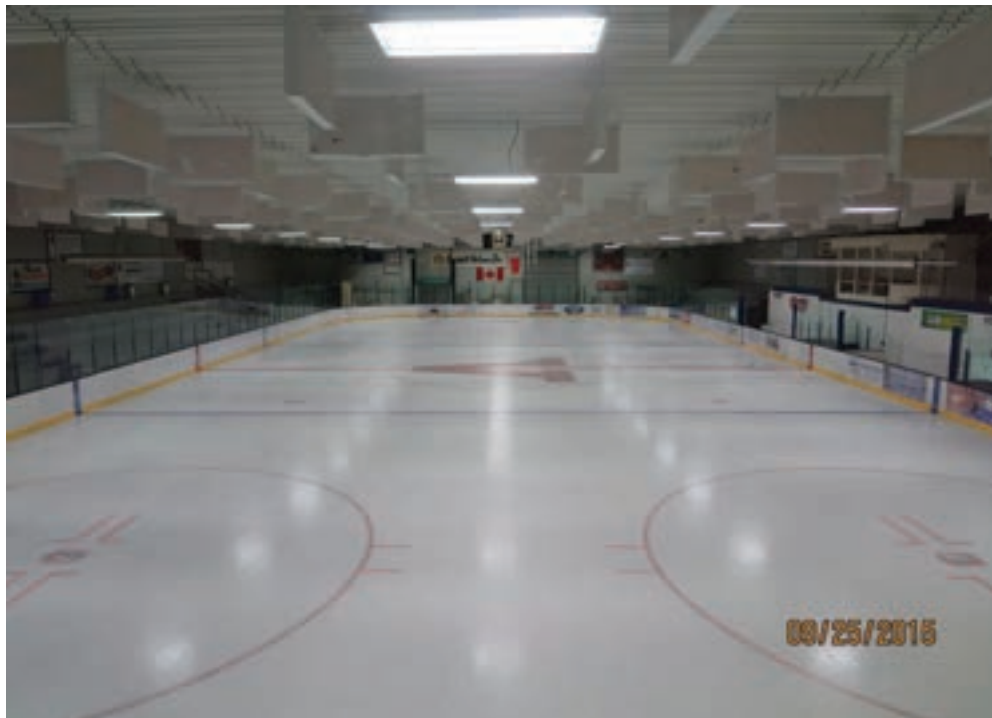
FIG #6.1

Also the Arena venue has suspended acoustic ceiling panels which appear to perform well and appear to be in good condition. (See Figures #6.1, #6.74 and #6.75).

There is very little storage in this building both for long term and short term storage. As a result nets are stored in the southeast corner of the arena, effectively blocking the southeast double door exit for the south seating area. (See Figures #6.1, #6.84 and #6.85). This is a safety concern and another location for net storage should be found, or the building expanded to provide additional convenient storage.

Lighting levels in the Main Arena area are good and the lighting technology is fairly current, replaced in approximately 2012. (See Figures #6.1, #6.6, #6.74 and #6.75).

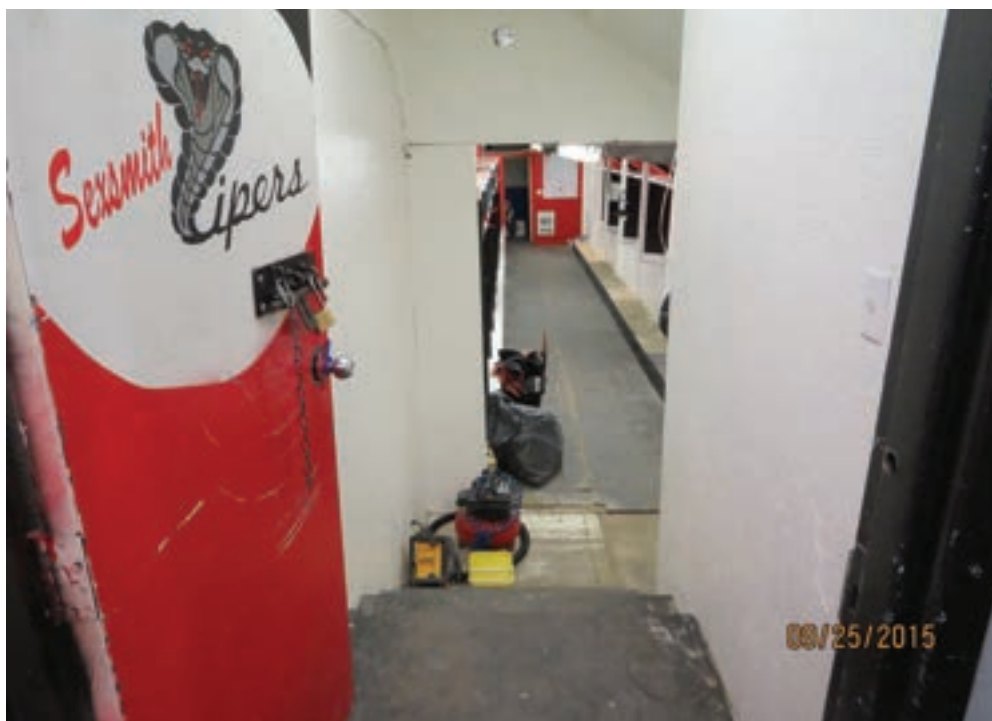
FIG #6.10

Feature Change Rooms have been constructed, through necessity, under the north Arena Seating area and the rooms are narrow and have low head room. (See Figures #6.10, #6.59, #6.60, #6.61, #6.11, #6.62 and #6.63). These rooms do not provide good space for hockey Change Rooms and the Washrooms are inadequate, or not functional. These rooms should be abandoned and a facility addition/expansion should be considered, to construct these required Change Rooms in another location. This will have a considerable capital cost impact and should be weighed with other building capital costs, against possibly construction a new Arena in another location.

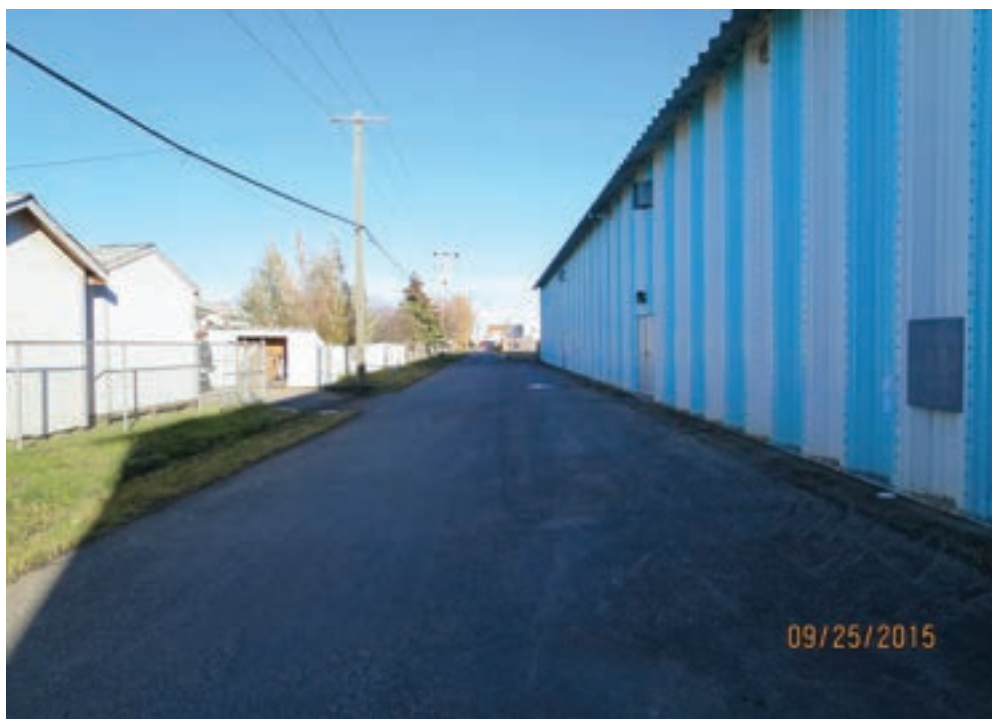
FIG #6.14

A detailed engineering analysis of the existing electrical infrastructure was not conducted. There is an existing 3-phase aerial service from an aerial power pole to the north of the building and feeding to the projected ice plant room. (See Figures #6.14 and #6.25). Interior electrical equipment generally appears to be original. (See Figure #6.93) with some upgrades (See Figure #6.94). The building house panels generally do not have breaker space available. (See Figure #6.95). The building may require some primary and secondary electrical upgrades in the next five years.

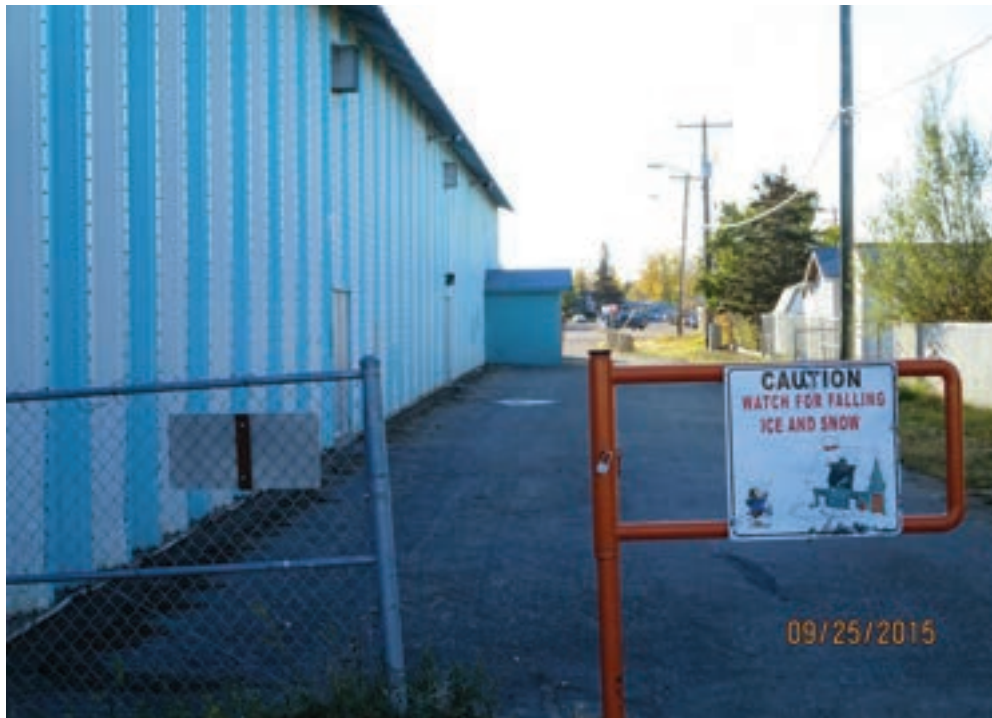
FIG #6.15

Roof gutters and rainwater downspouts directing water away from the building are not present and the building likely experiences soil erosion on the south grassed area. (See Figure #6.24). Also the building staff and existing signage identifies that the north lane experiences snow sliding in the winter and this is a safety concern. (See Figures #6.14, and #6.15). When re-roofing is undertaken, gutters, downspouts and concrete splash pads should also be added.

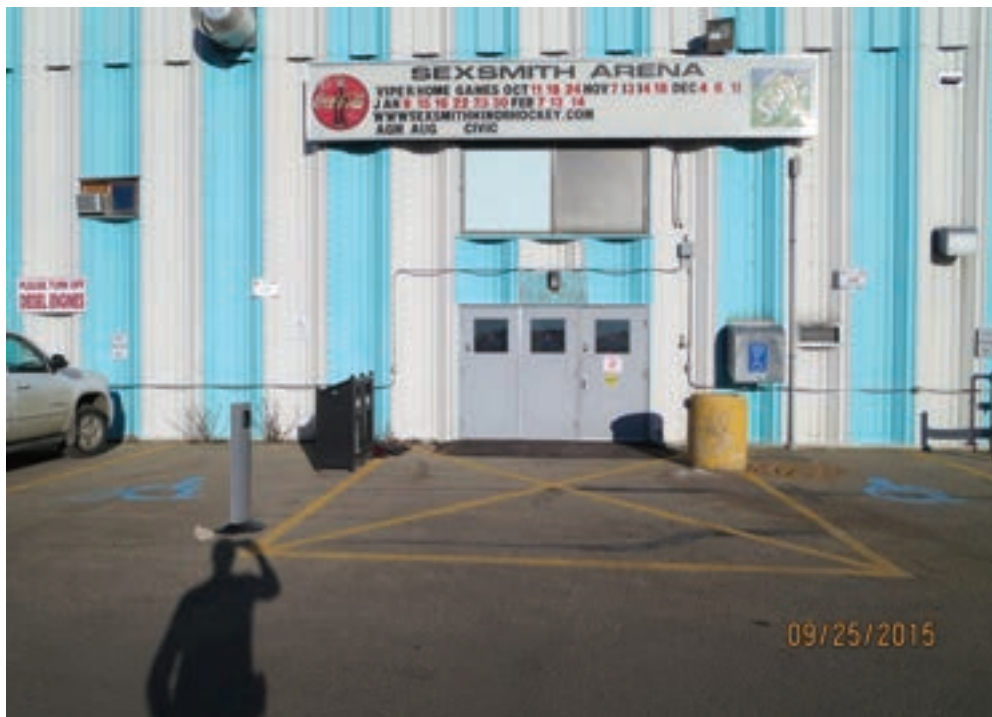
FIG #6.21

The Arena Main Entrance on the west side is at parking grade and provides barrier free access to the facility. (See Figure #6.21).

Also (See Figures #6.26, #6.27 and #6.32), these doors and frames require replacement. Generally the majority of newer doors and frames require painting. (See Figures #6.21, #6.24 and #6.34). Painting should be undertaken to extend the life of the doors and frames.

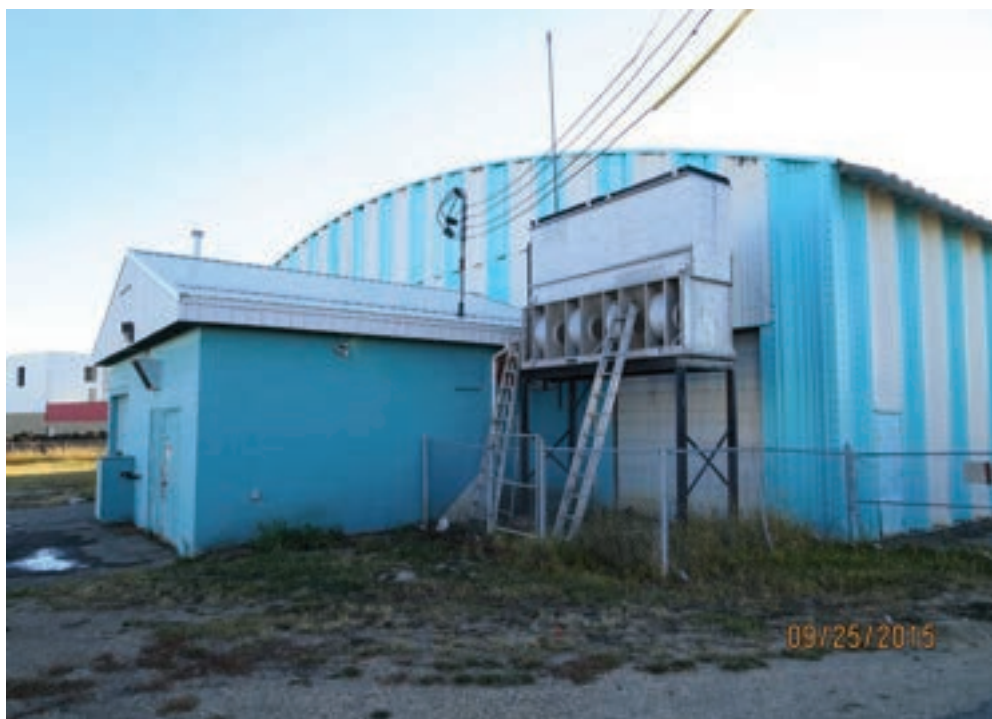
FIG #6.25

Roof gutters and downspouts are present on all other projected building elements and all are clad in pre-finished standing seam metal roofing. These roof areas appear to be in acceptable condition. (See Figures #6.25, #6.26 and #6.28).

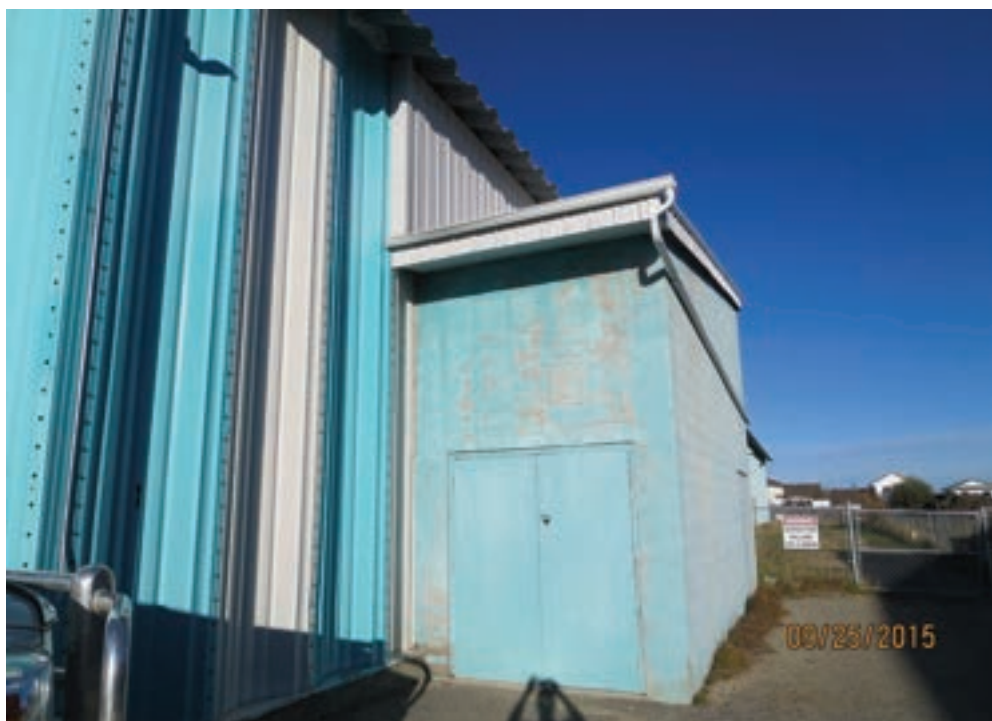
FIG #6.26

Concrete block wall assemblies of the south projected exit are show signs of block deterioration, efflorescence and paint failure. Further structural review of the concrete block is recommended and at a minimum re-painting is required. (See Figures #6.26, #6.27 and #6.32).

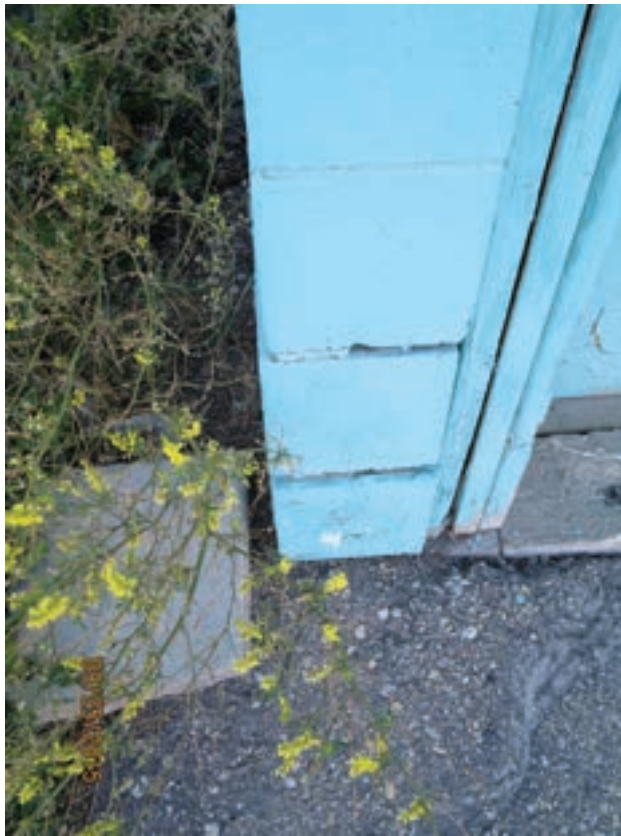
FIG #6.28

The Arena is a typical corrugated steel framed Quonset building, with a barrel curved roof, (See Figures #6.22 and #6.23). Building sits on concrete foundations; exterior walls are corrugated ribbed metal panels. (See Figures #6.15 and #6.24). Projected rear Ice Plant room and Ice Re-surfacer room spaces, appear to be load bearing concrete block walls with wood framed trussed, peaked roof structure. (See Figures #6.19 and #6.25). Projected exit area elements are load bearing concrete block walls with wood framed roof structures. (See Figures #6.26, #6.27 and #6.28). The building is not sprinklered.

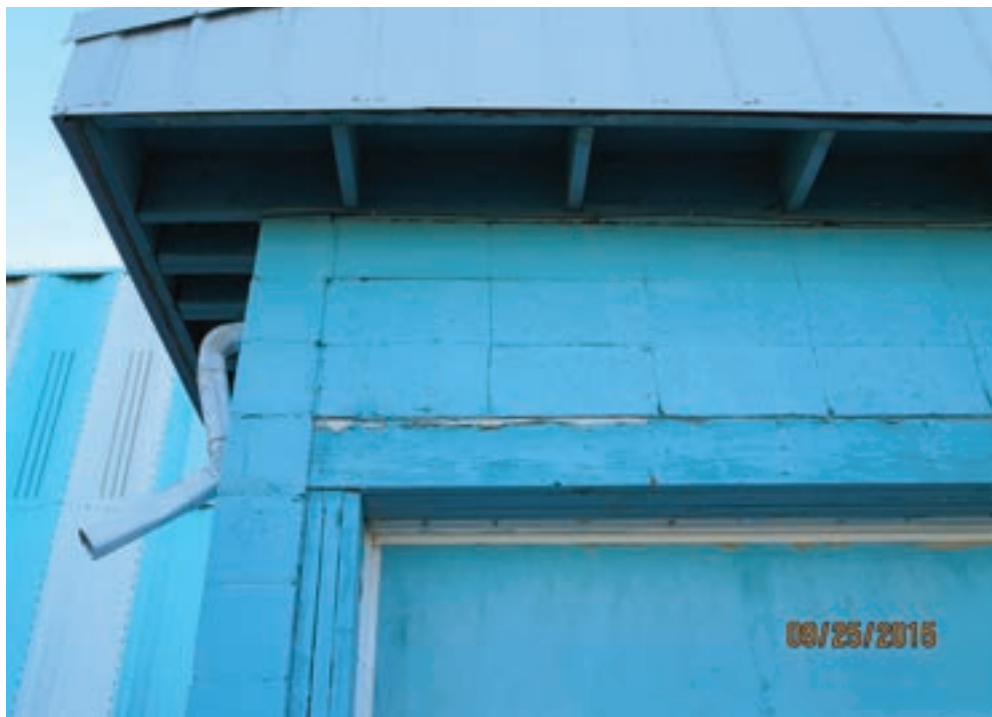
FIG #6.29

Wall assemblies of the rear concrete block projected building appear to be generally in acceptable condition. (See Figures #6.17, #6.19 and #6.25). However some concrete block deterioration was observed (See Figure 6.29) and should be reviewed and rectified. Also the rough opening framing and door installations of the Ice Plant and Ice-resurfacer Room doors is not standard construction. (See Figures #6.19, #6.29 and #6.30). These door openings should be corrected or re-framed and the doors replaced.

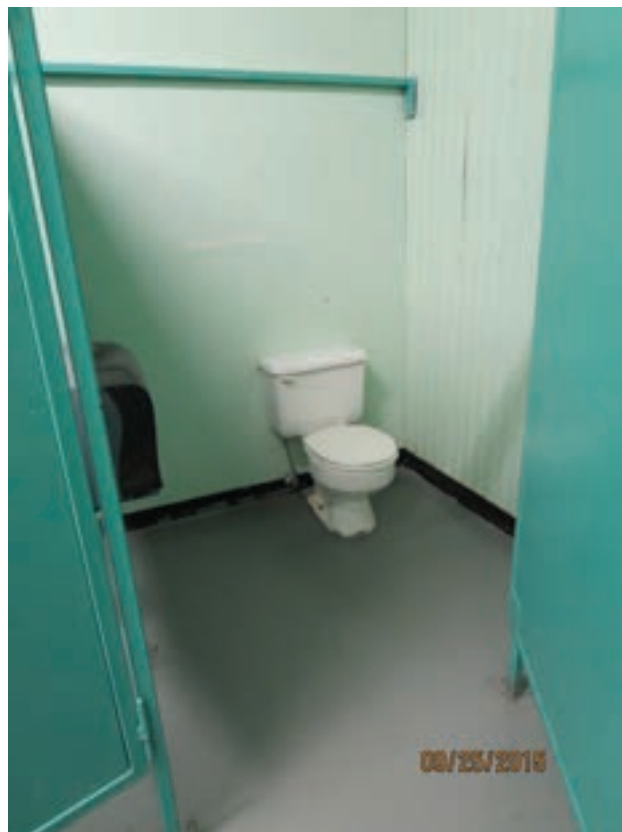
FIG #6.39

Public Washrooms off the upper Arena Lobby are in acceptable condition, however the washrooms are not barrier free. (See Figures #6.39, #6.40, #6.41 and #6.42). Although well maintained, finishes in these washrooms are somewhat tired and replacement and updating should be considered in the next five years.

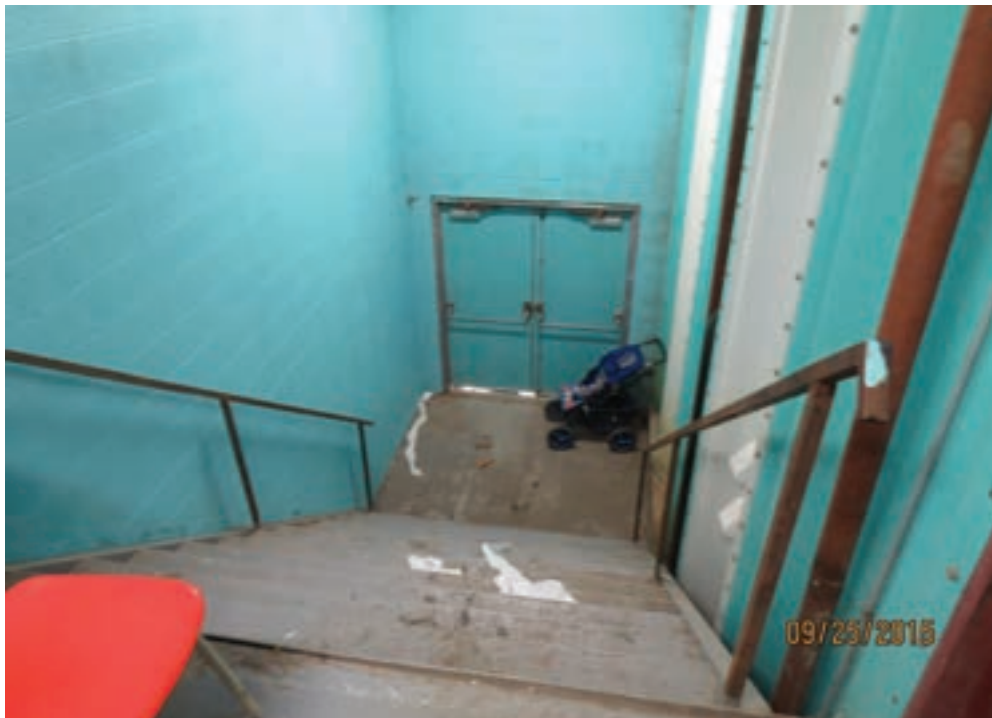
FIG #6.52

Also there are general areas randomly through the facility that require updating, repair and finish replacement. (See Figures #6.52, #6.53, #6.54, #6.55, #6.56, #6.57 and #6.58).

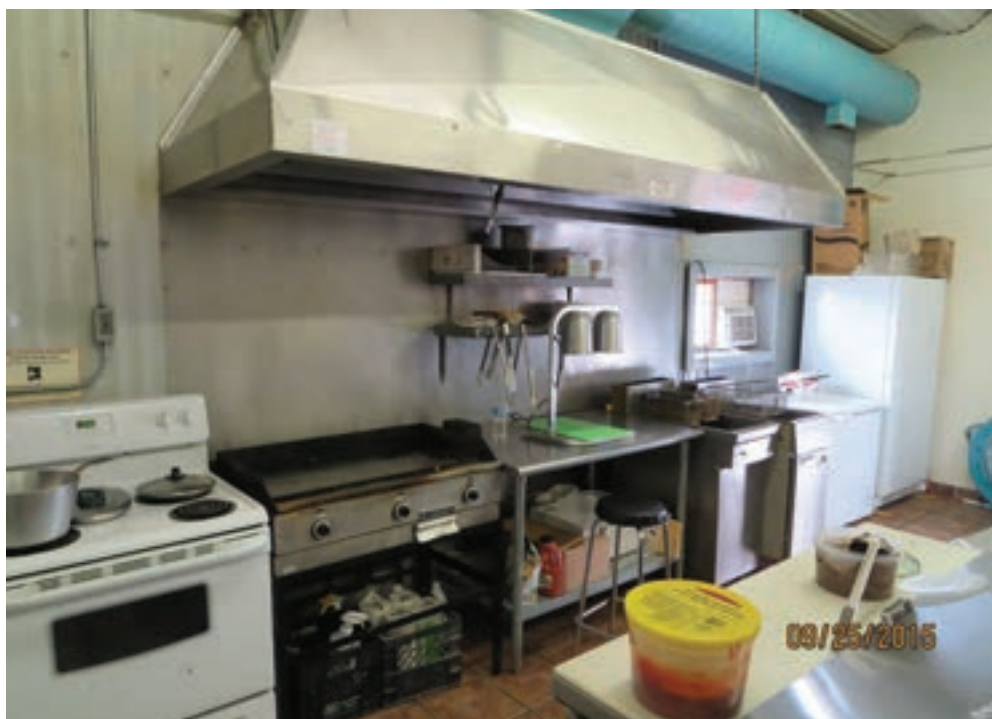
FIG #6.64

Arena Concession finishes appears to be in acceptable condition, although the finishes are tired. (See Figure #6.64, #6.65, #6.66 and #6.67). Re-finishing of the Concession should be considered. Concession hood does have a fire suppression system.

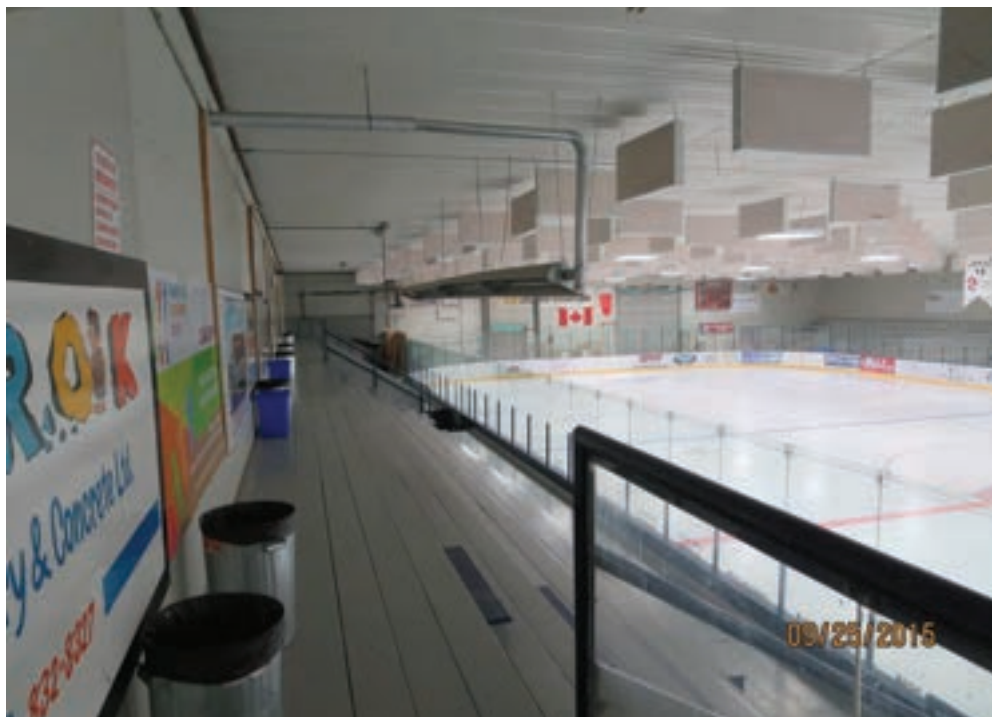
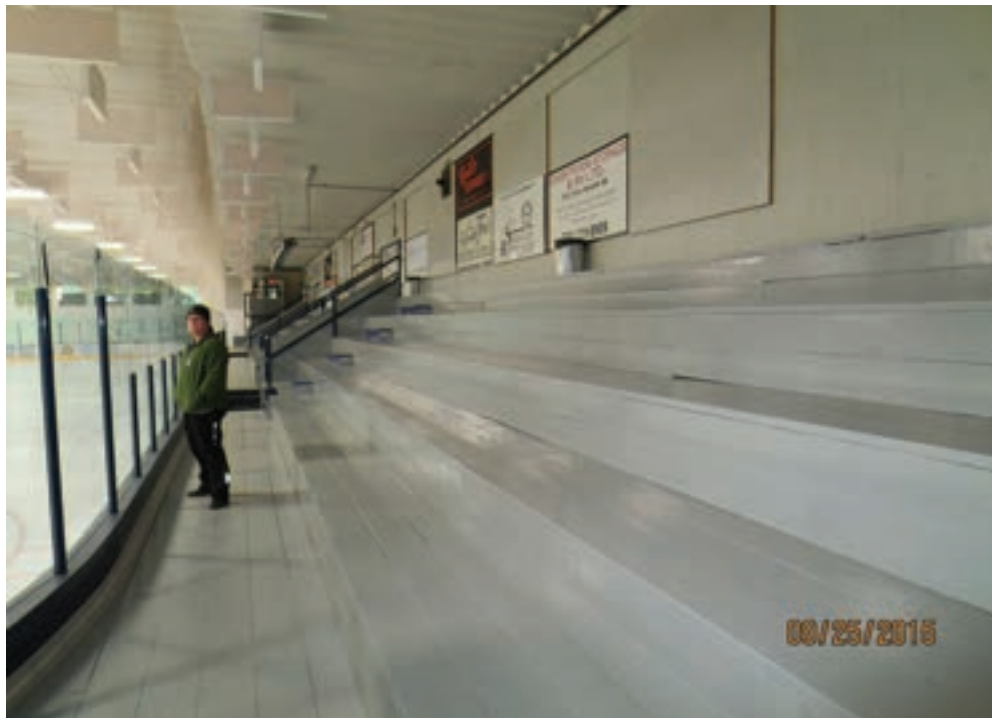
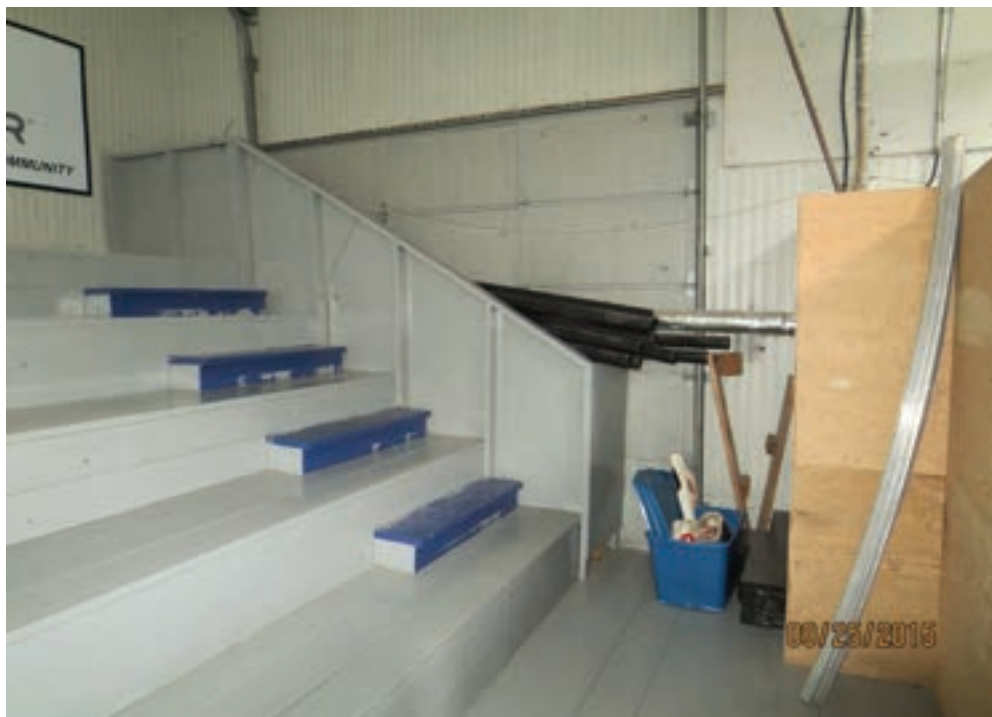
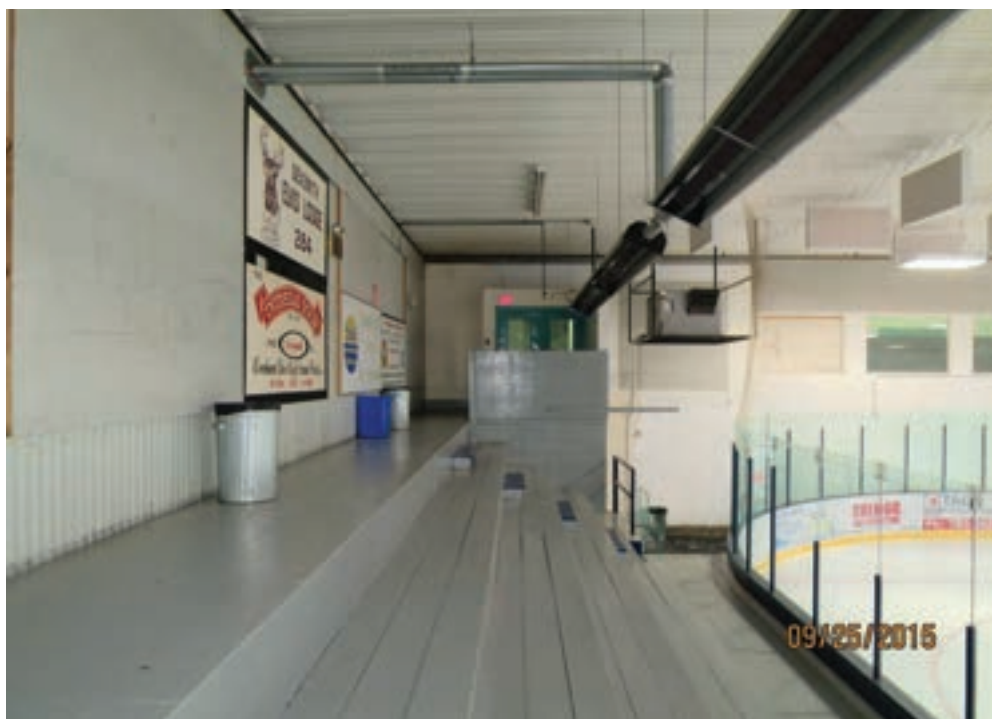
Arena seating area finishes appear to be durable and in acceptable condition, however some re-painting is required. (See Figures #6.68, #6.69, #6.70 and #6.71). There is also barrier free access to the north Seating Area from the Upper Lobby with a Barrier Free Viewing Area. (See Figures #6.72 and #6.73).
