# GRANDE PRAIRIE FACILITIES ANALYSIS REPORT

# Facilities Analysis Report

**Hythe Arena**

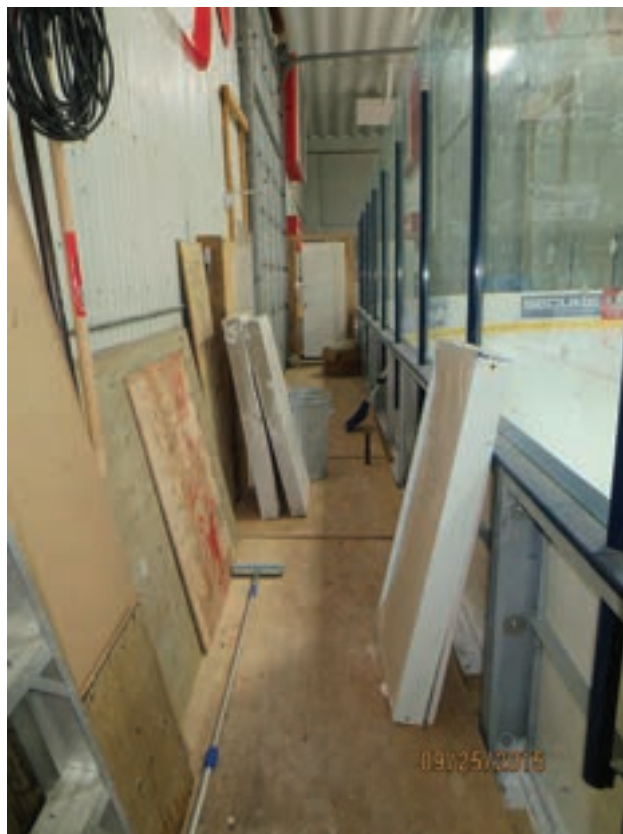
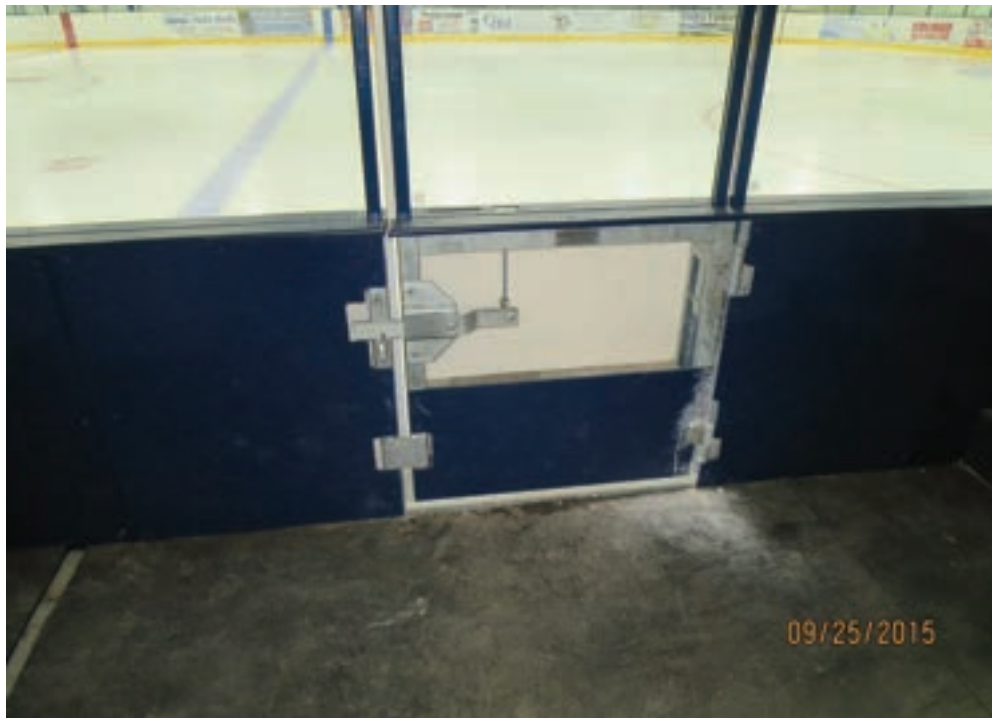
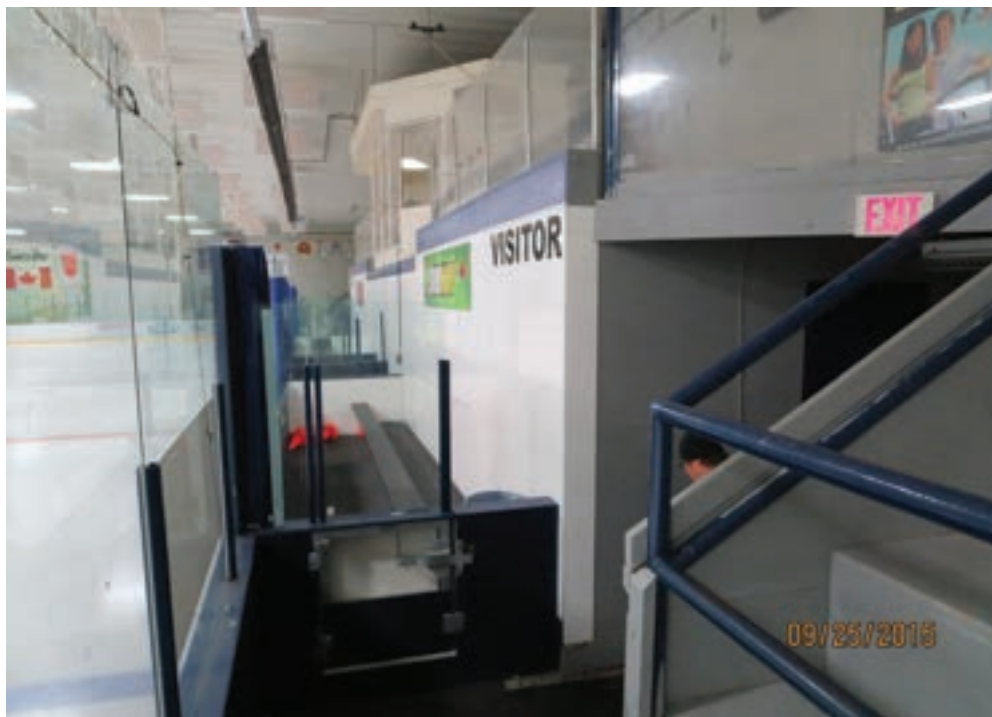
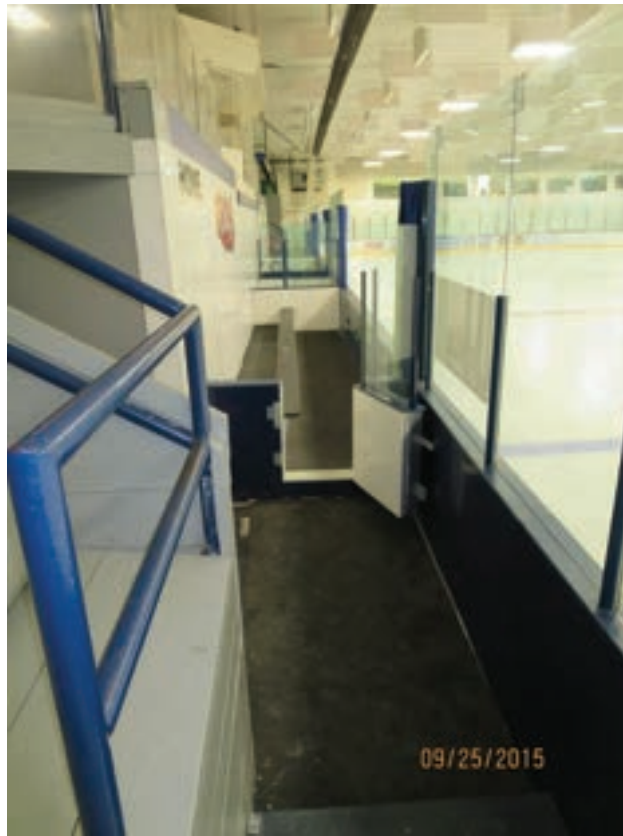
Ice Sheet Dasher Boards appear to be in good condition and are a newer technology steel system, approximate replacement was 2013. (See Figures #6.80, #6.81, #6.82 and #6.83). The system should perform for years to come.

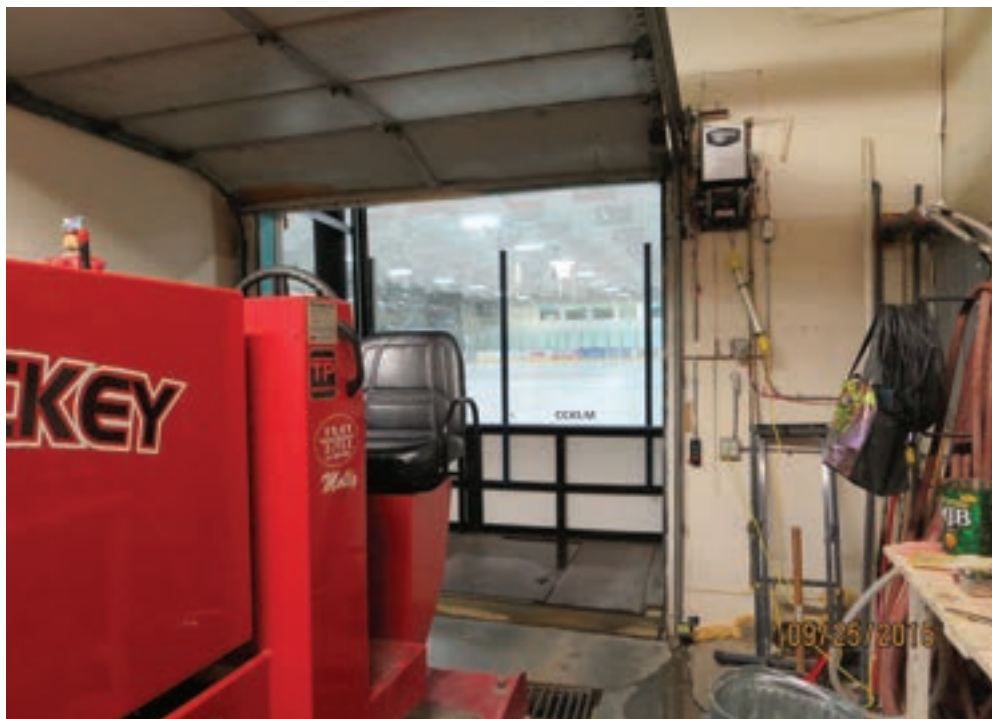
FIG #6.86

Ice Re-surfacer Room door from the Arena venue is an overhead door and is not rated, (See Figure #6.86). This creates a non-rated door condition that is not code compliant. The door should be replaced with rated coiling shutter.

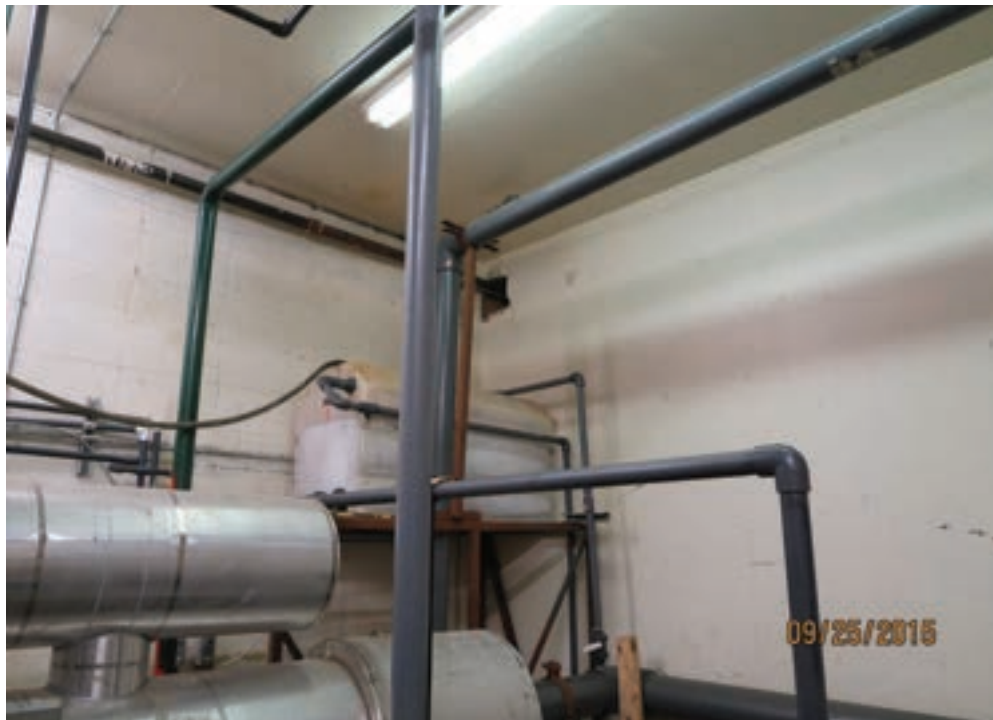
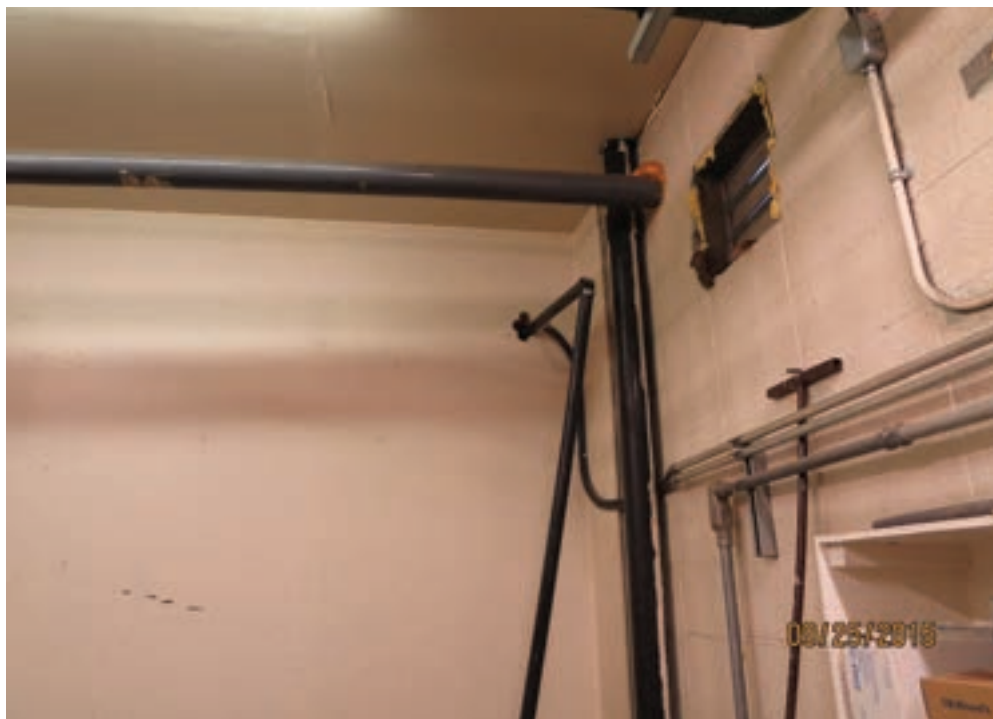
Walls forming the Ice Plant Room and the Ice resurfacer Room do not appear to be constructed as fire rated assemblies and penetrations through the walls are not fire sealed. (See Figures #6.87 and #6.88). These ratings are required by code and the wall assemblies should be completed/rectified immediately. Also the door dividing the two rooms does not appear to be a rated door and frame. (See Figure #6.89), this door and frame should be replaced.

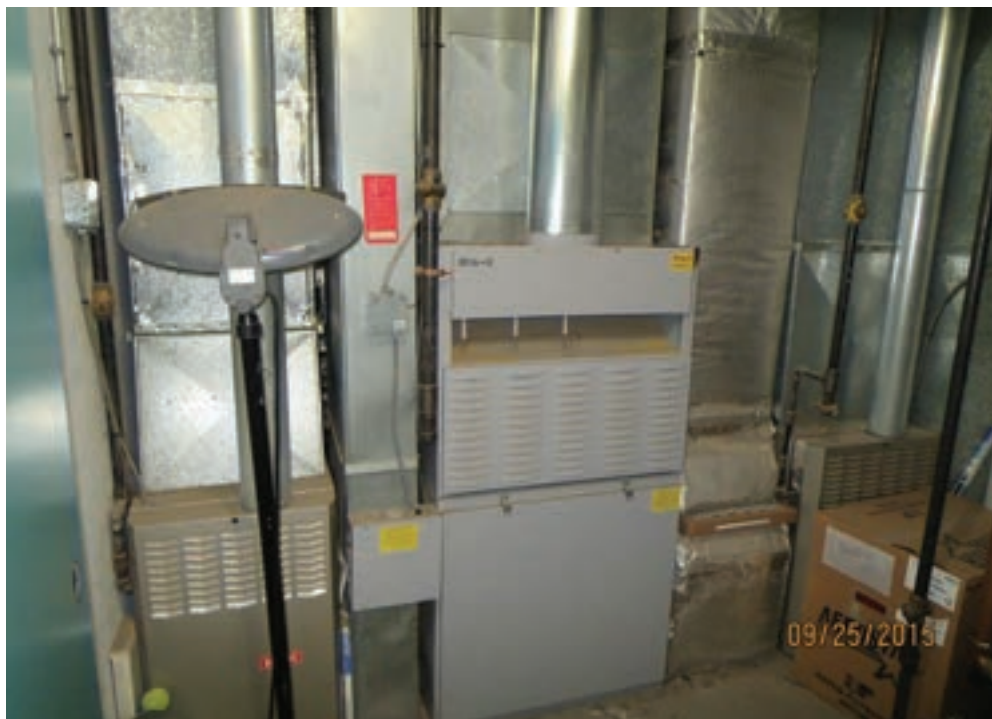
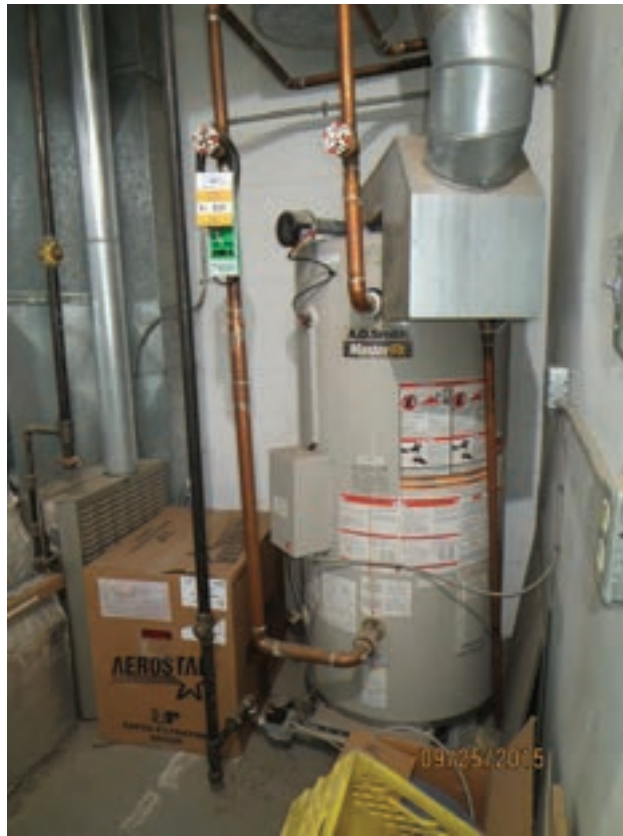
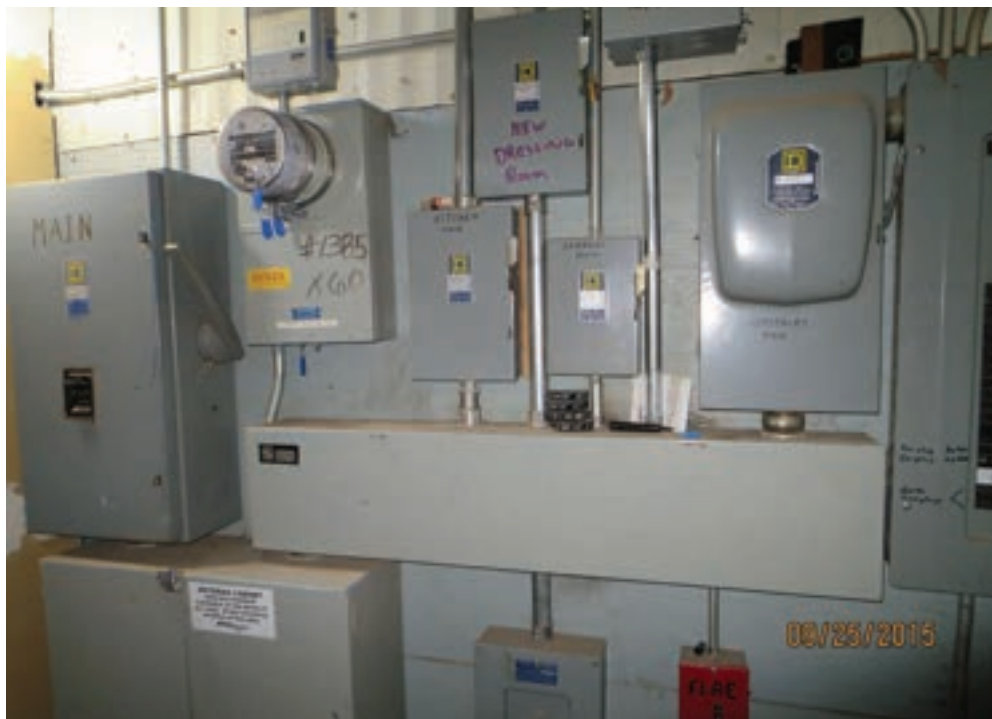
A detailed engineering analysis of the existing mechanical infrastructure was not conducted; however there was evidence, or maintenance staff knowledge of furnace replacement in approximately 2011 and hot water tank replacement in approximately 2012, throughout the building. (See Figures #6.90, #6.91 and #6.92). Duct work is likely original to the building. Generally the mechanical infrastructure appeared acceptable, but ongoing maintenance is required. Also the Main Arena appears to be dehumidified.

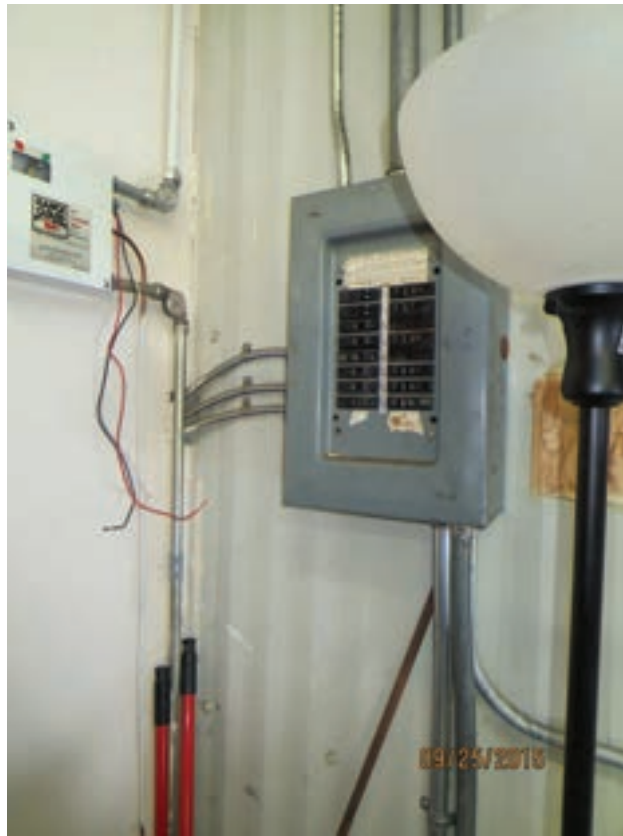
FIG #6.95

A detailed engineering analysis of the existing electrical infrastructure was not conducted. There is an existing 3-phase aerial service from an aerial power pole to the north of the building and feeding to the projected ice plant room. (See Figures #6.14 and #6.25). Interior electrical equipment generally appears to be original. (See Figure #6.93) with some upgrades (See Figure #6.94). The building house panels generally do not have breaker space available. (See Figure #6.95). The building may require some primary and secondary electrical upgrades in the next five years.

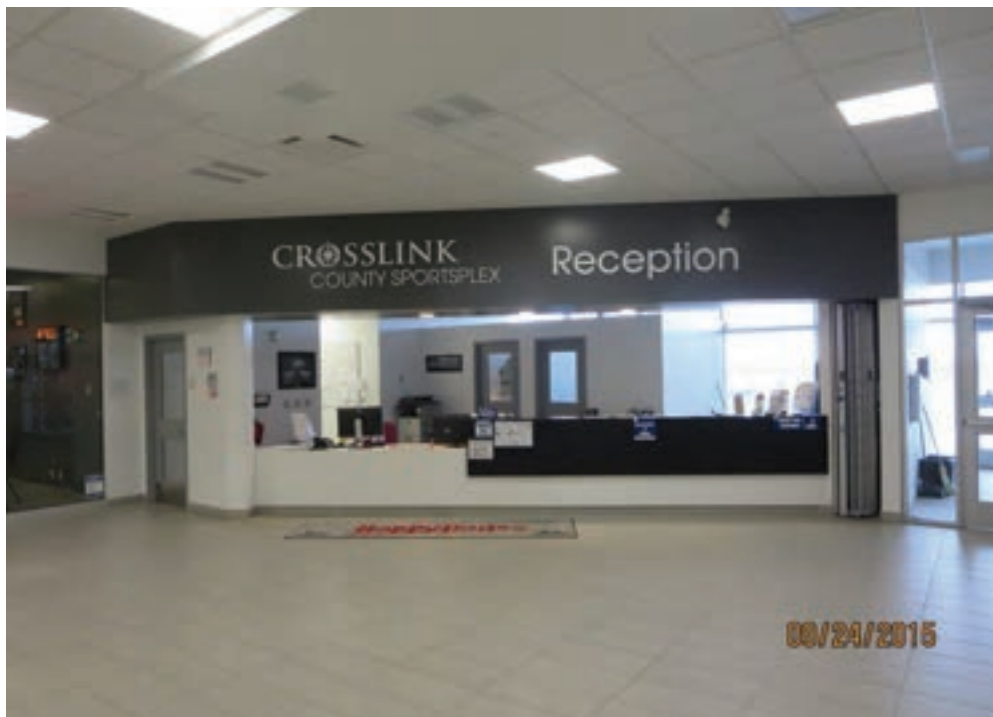
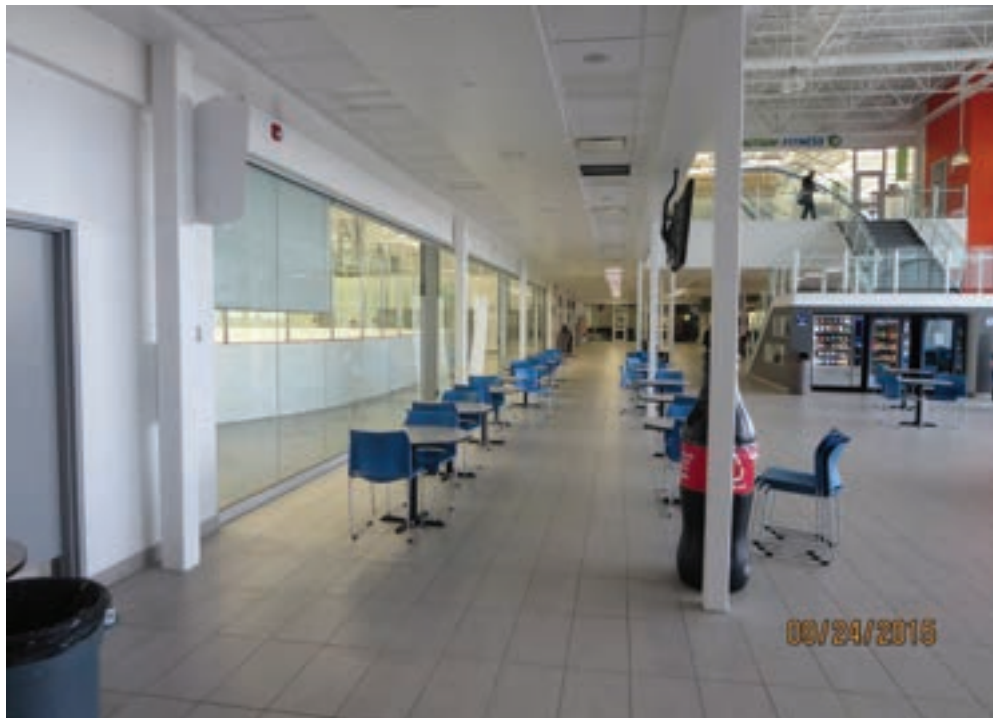
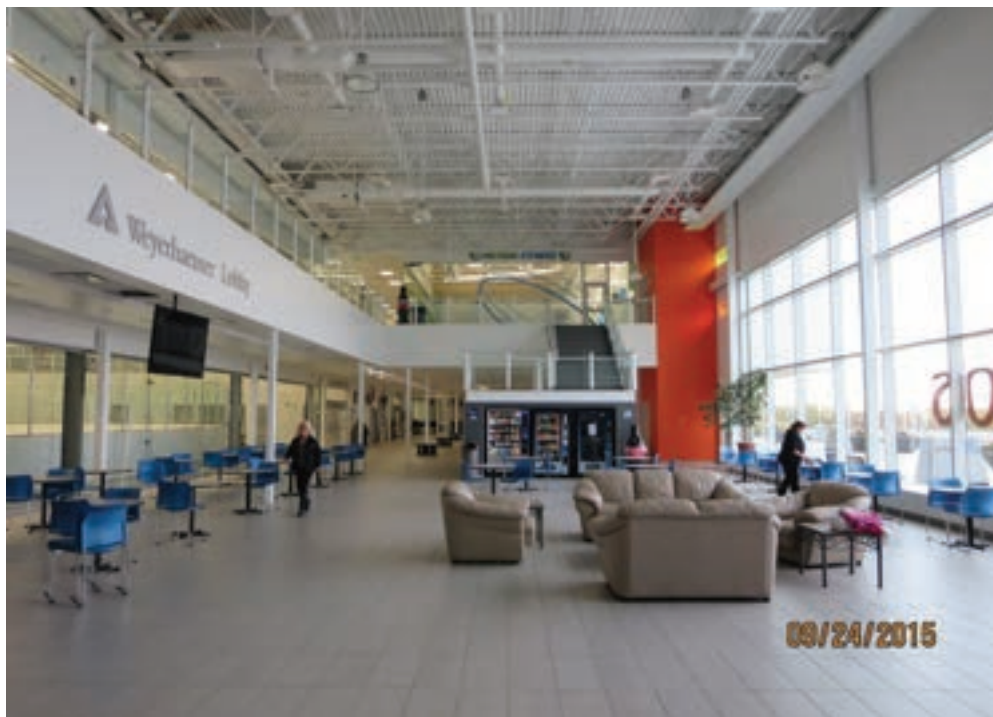
The Main Entrance (See Figures #7.62 and #7.63) and Main Floor Lobby areas of the Concourse are virtually new, with durable finishes and no noted deficiencies. (See Figures #7.1, #7.2, #7.3, #7.4, #7.5, #7.6, #7.7, #7.8, #7.9 and #7.10). The Second Floor of the Concourse is also virtually new, with durable finishes and no noted deficiencies. (See Figures #7.18, #7.19, #7.20, #7.21 and #7.22). The main entrance and access to the second level is barrier free.

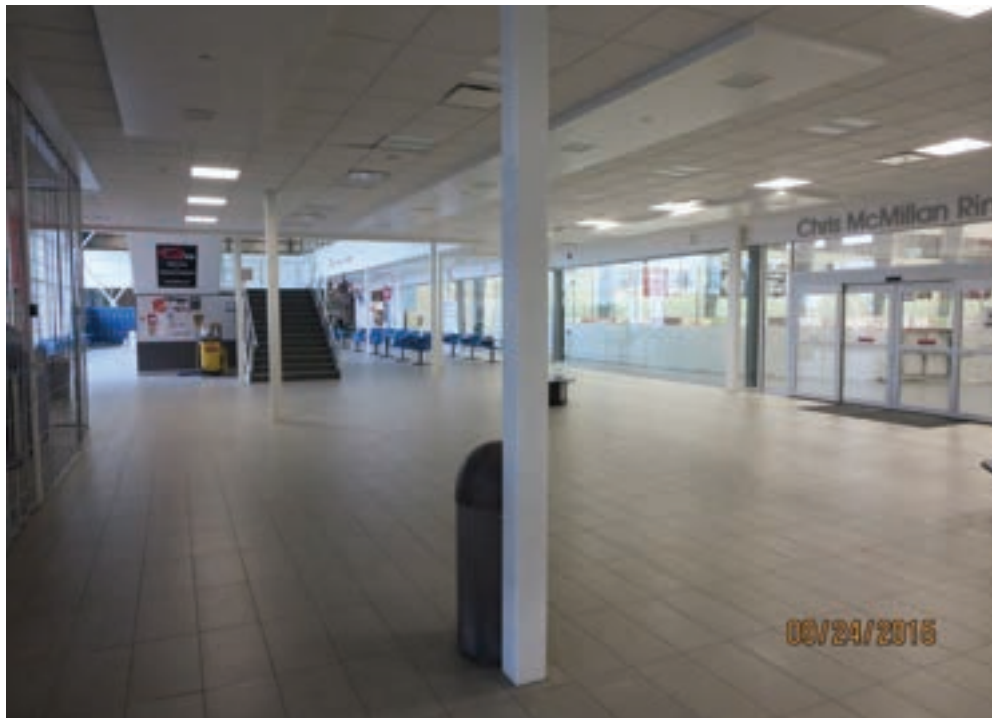
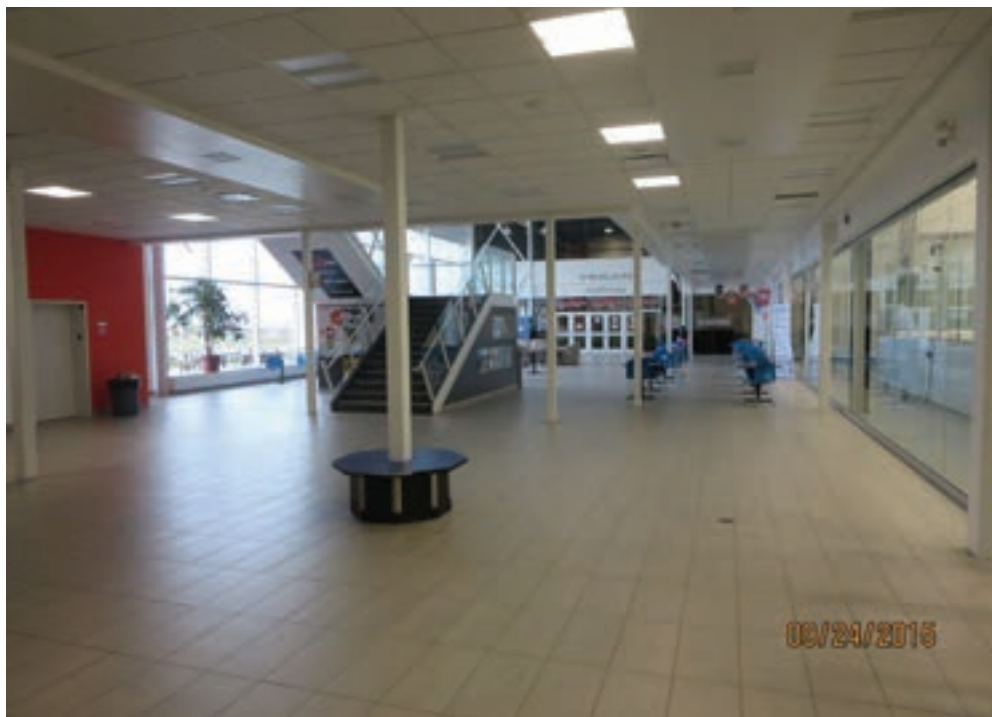
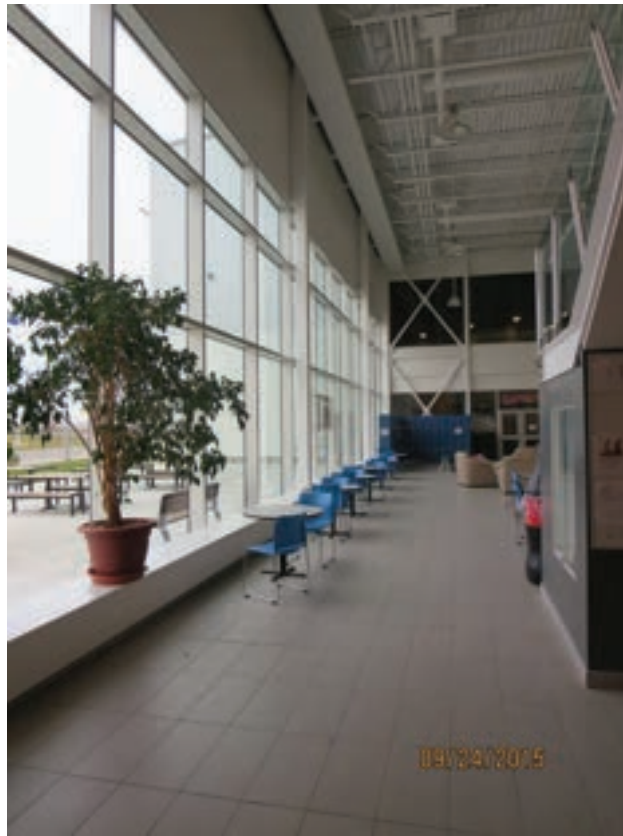
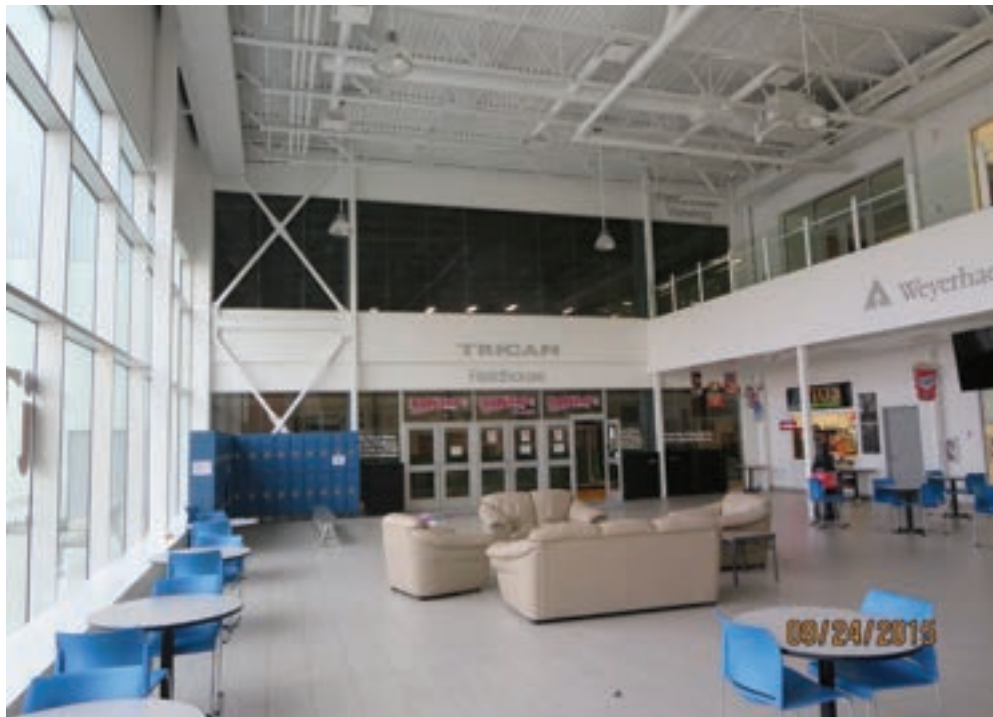
Main Concourse two storey component, including the main floor Administration Area and second floor Fitness area is typical steel columns with steel joists and steel deck. Walls are non-load bearing steel studs. (See Figures #7.3, #7.4, #7.5, #7.6, #7.7 and #7.8). Interior core areas for the Arenas and the Fieldhouse are a combination load bearing and non-load bearing concrete block walls supporting cast in place concrete second floors, with intermediate concrete columns. (See Figures #7.51, #7.52 and #7.53). The building is fully sprinklered throughout.

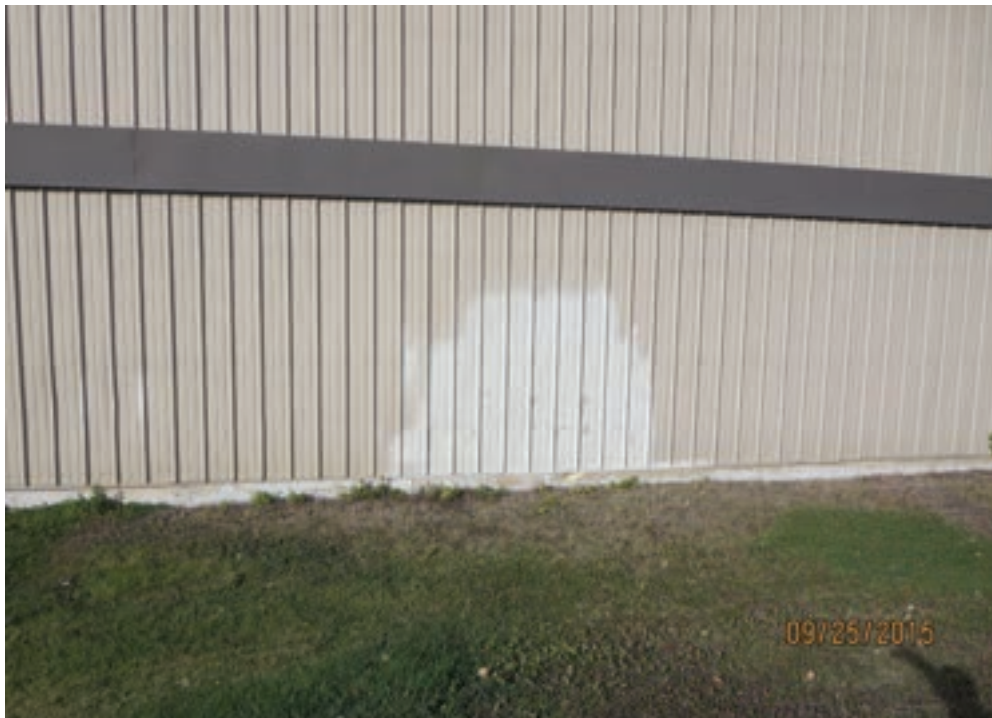
FIG #9.26

The exterior wall assemblies of the Arena are pre-finished vertical metal wall panels with assumed bagged batt insulation, typical of this style of building. (See Figures #9.17, #9.18, #9.21 and #9.22). Exterior profiled metal wall cladding has some damage (See Figure #9.26) but generally appears to be in acceptable condition, although the cladding is likely original. There appears to be an issue with graffiti in the neighborhood, (See Figures #9.23 and #9.27). Aesthetically re-painting the base cladding of the building to eliminate the graffiti touch-up would be recommended, and then an overcoat of anti-graffiti coating should be considered. Cladding repairs or localized replacement could be undertaken before the painting is done.

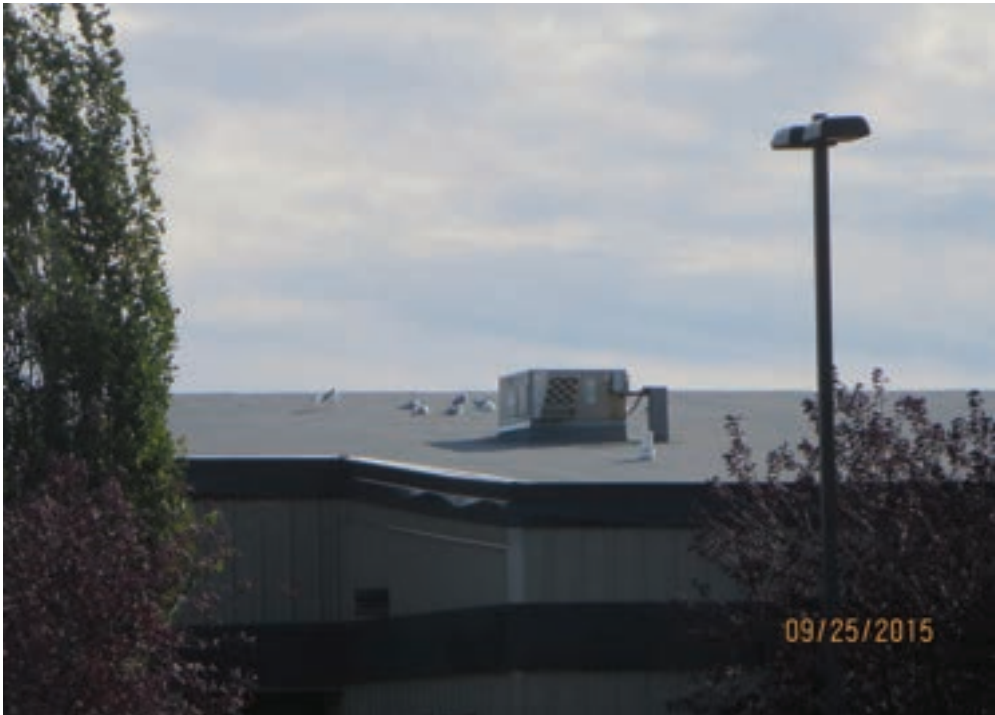
FIG #9.29

The roof membrane of the facility appears to be a roll applied 2-ply SBS roofing and it was installed in approximately 2010. (See Figures #9.29 and #9.30). This roof should perform well for years to come.

A detailed engineering analysis of the existing mechanical infrastructure was not conducted; however the building is serviced by rooftop and exterior air handlers. (See Figure #9.29, #9.30 and #9.85). Mechanical spaces are very well kept and the equipment is well maintained and appears to be functioning well. (See Figures #9.86, #9.87 and #9.88). Generally the mechanical infrastructure appeared in good condition, but ongoing maintenance is required.

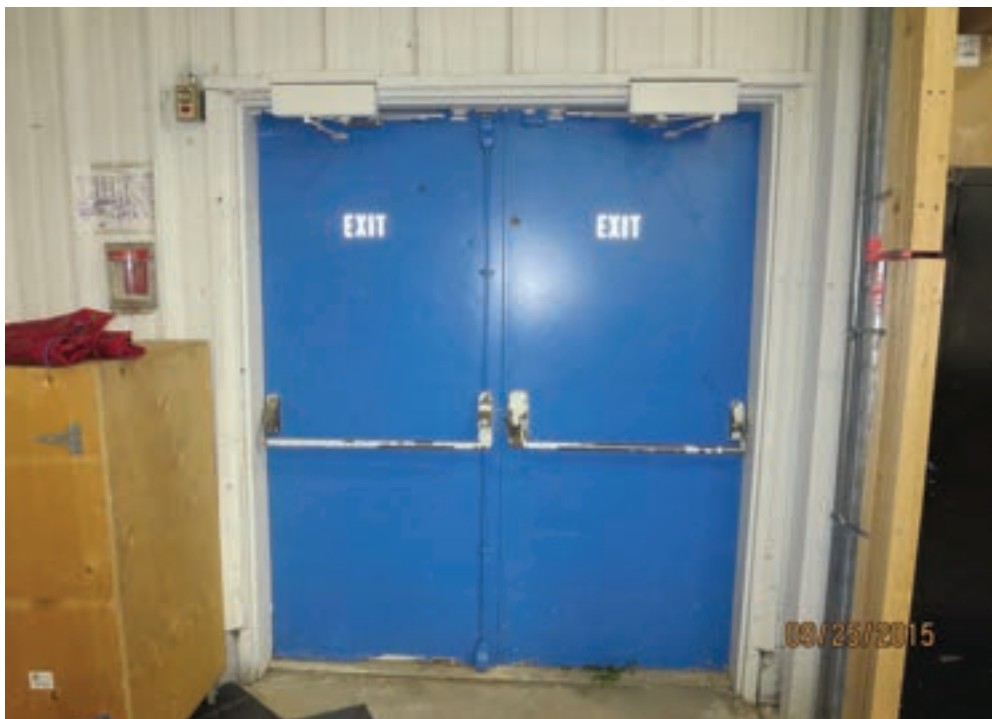
FIG #9.31

Exterior doors and frames on the Arena portion of the facility are original in several locations and replacement is warranted. (See Figures #9.31, #9.32 and #9.33).

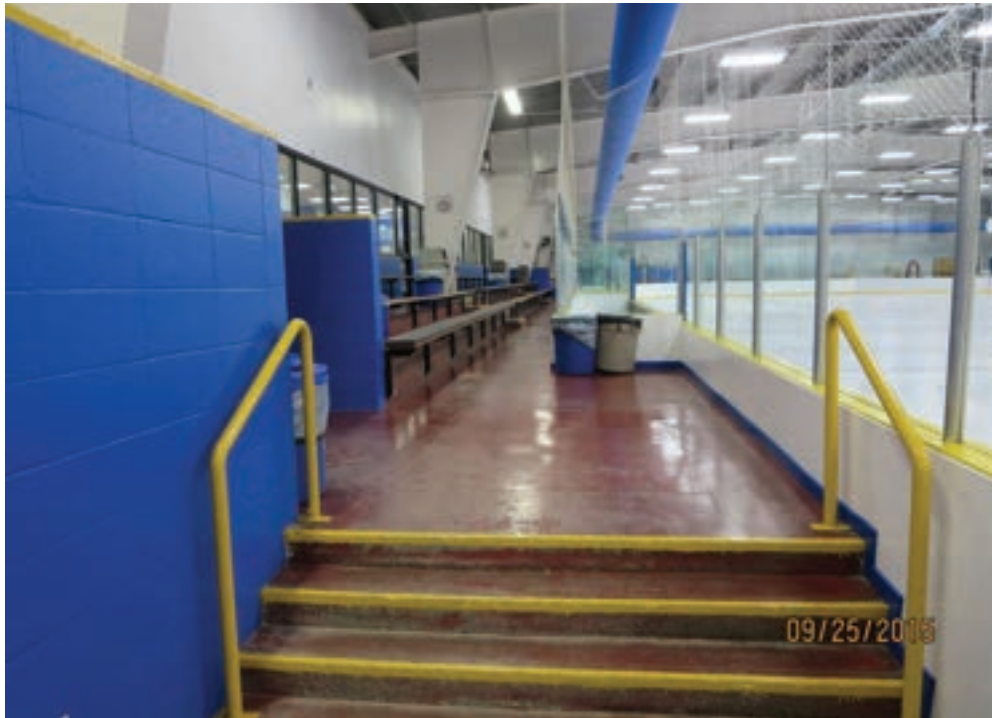
FIG #9.34

Arena seating area finishes appear to be durable and in acceptable condition. (See Figures #9.34 and #9.53).

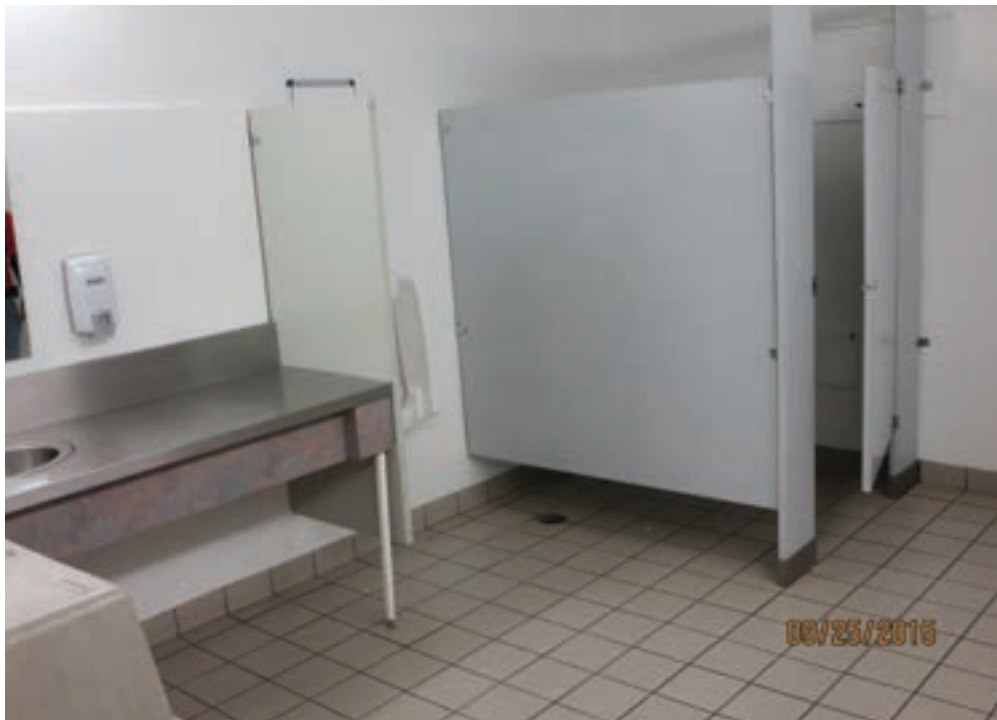
FIG #9.36

Public Washrooms off the Arena Lobby are in acceptable condition, however the washrooms are not completely barrier free. (See Figures #9.36, #9.37, #9.38 and #9.39). The Washrooms are well maintained, and finishes appear to be performing.

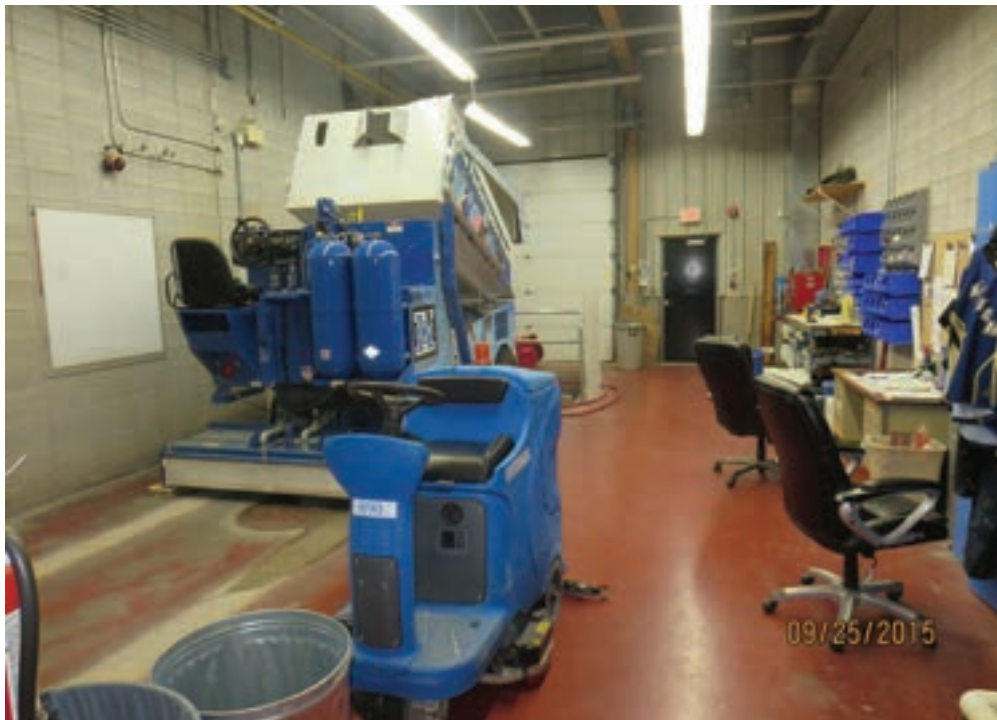
FIG #9.81

Ice Re-surfacer Room appears to generally be in acceptable condition. Ice melt pit appears to perform and room is ample in size. (See Figure #9. 81, #9.82 and #9.83). The man door and frame from the Arena area is in poor condition and should be replaced (See Figure #9.84).

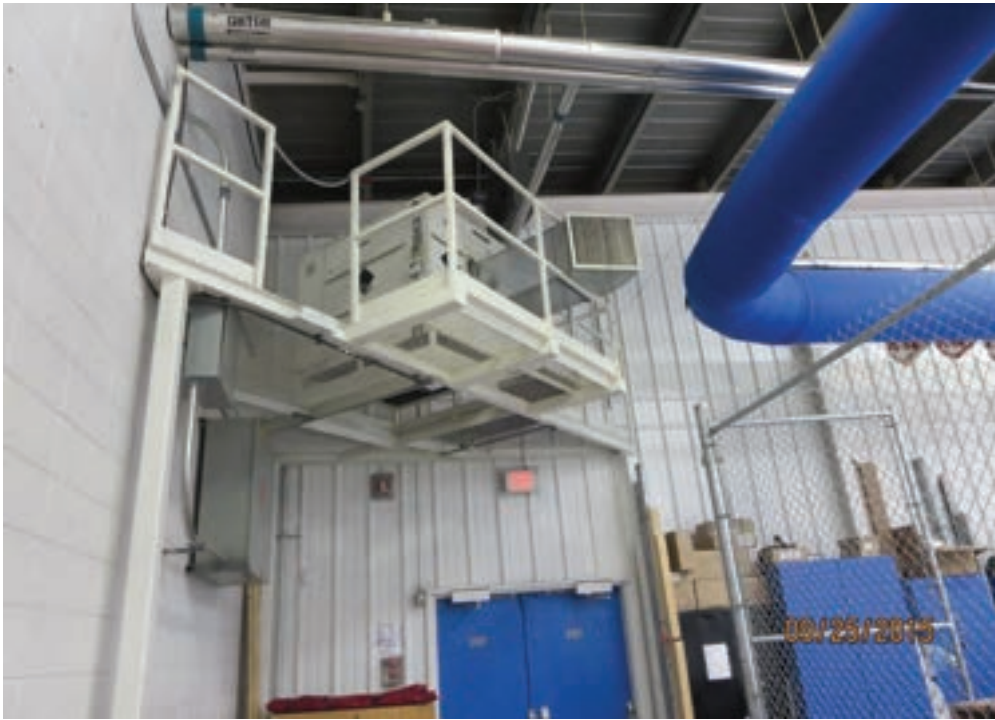
FIG #9.89

Also the Main Arena appears to be dehumidified. (See Figures #9.89 and #9.90).

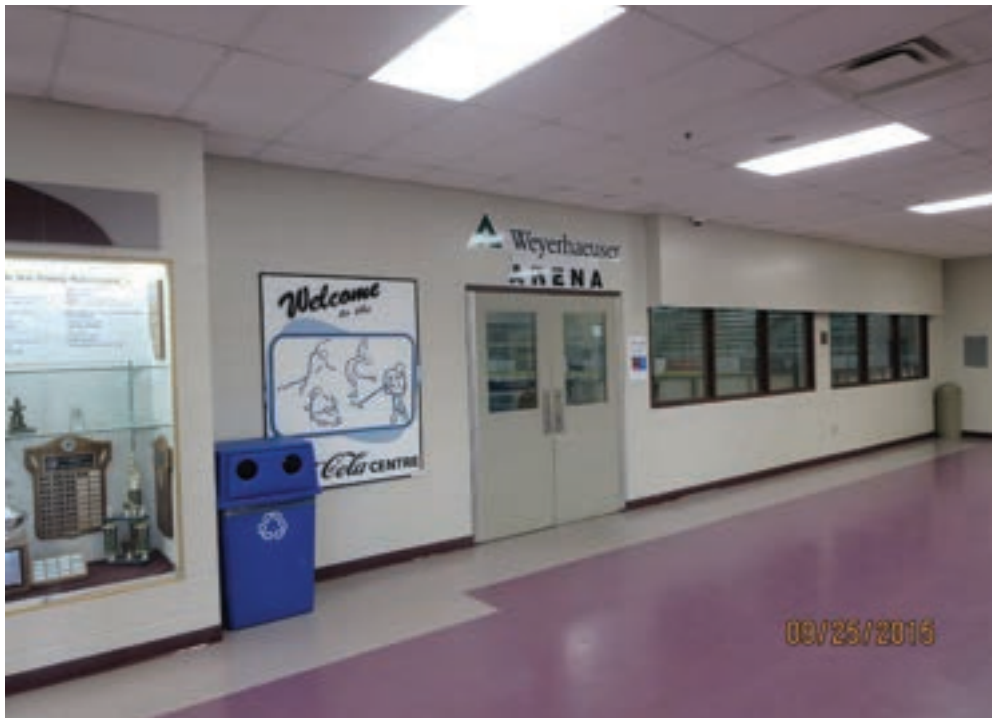
FIG #10.1

The overall facility houses two old regulation NHL ice sheets both with seating. (See Figures #10.1 and #10.2). The north western sheet (Weyerhaeuser Arena) has seating on both sides with an estimated capacity of approximately 1,700 people. (See Figure #10.3, #10.4, #10.5 and #10.6).

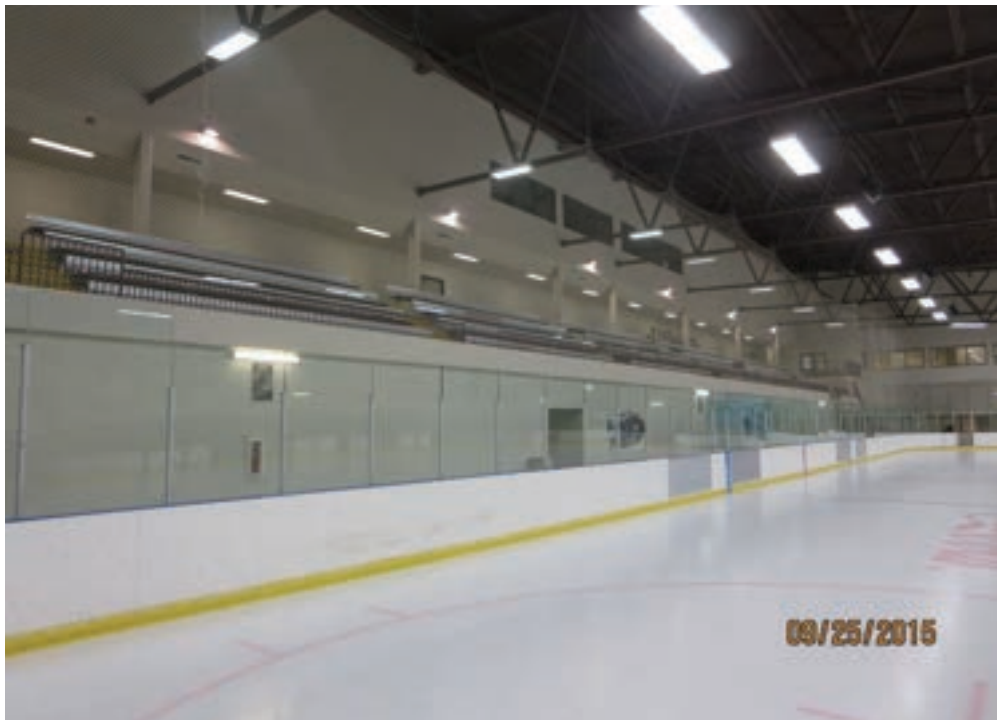
FIG #10.7

The south eastern sheet (The Academy Arena) has seating on one side with an estimated seating capacity of approximately 750 people. (See Figure #10.7, #10.8, #10.9 and #10.10). There is an main floor Administration/Reception area with offices. (See Figure #10.11). The Main Entrance is at grade (See Figure #10.12) with direct access to the Arena Lobby with table seating area and a central Concession. (See Figures #10.1, #10.2, #10.13, #10.14, #10.15 and #10.16). Also there are Public Washrooms off of the Lobby. (See Figure #10.17). Each Arena has 5 regular Change Rooms and one feature Change Room, accessed from the Lobby down a corridor. The change rooms then provide direct access into the ice areas. (See Figures #10.18). There are also an off-gender and referee Change Rooms, which are also accessed from the corridor and then they provide direct access to the ice area.

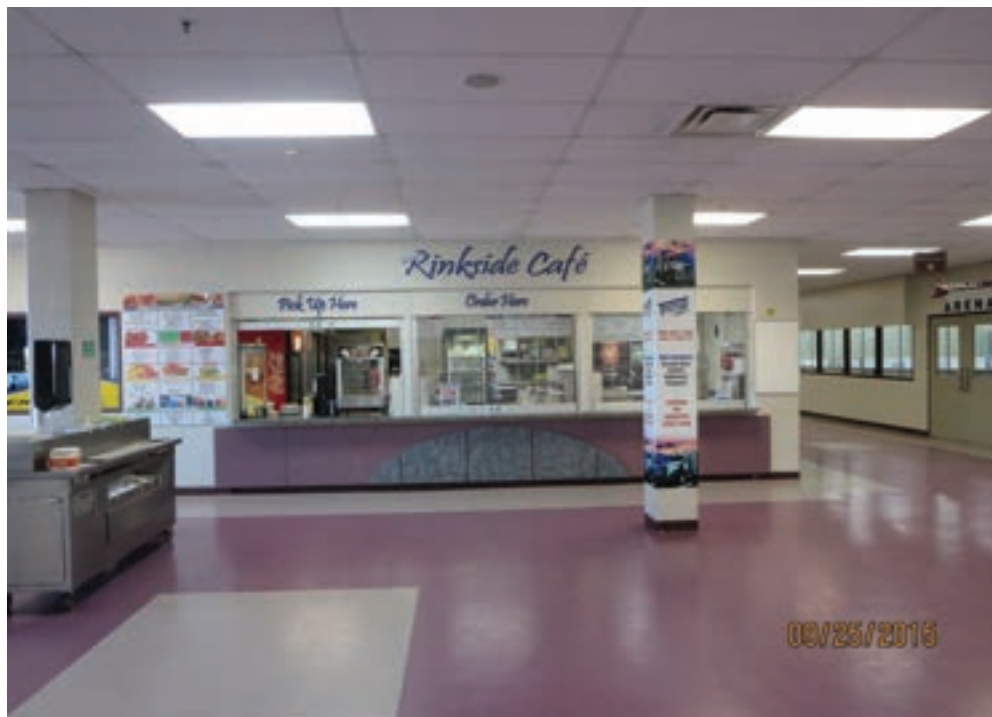
FIG #10.13

Arena Concession finishes appear to be in acceptable condition, and the Concession is well maintained. (See Figures #10.13, #10.80 and #10.81). Concession is a leased space and so costs related to this space are not carried in this report.
