# GRANDE PRAIRIE FACILITIES ANALYSIS REPORT

# Facilities Analysis Report

**Hythe Arena**

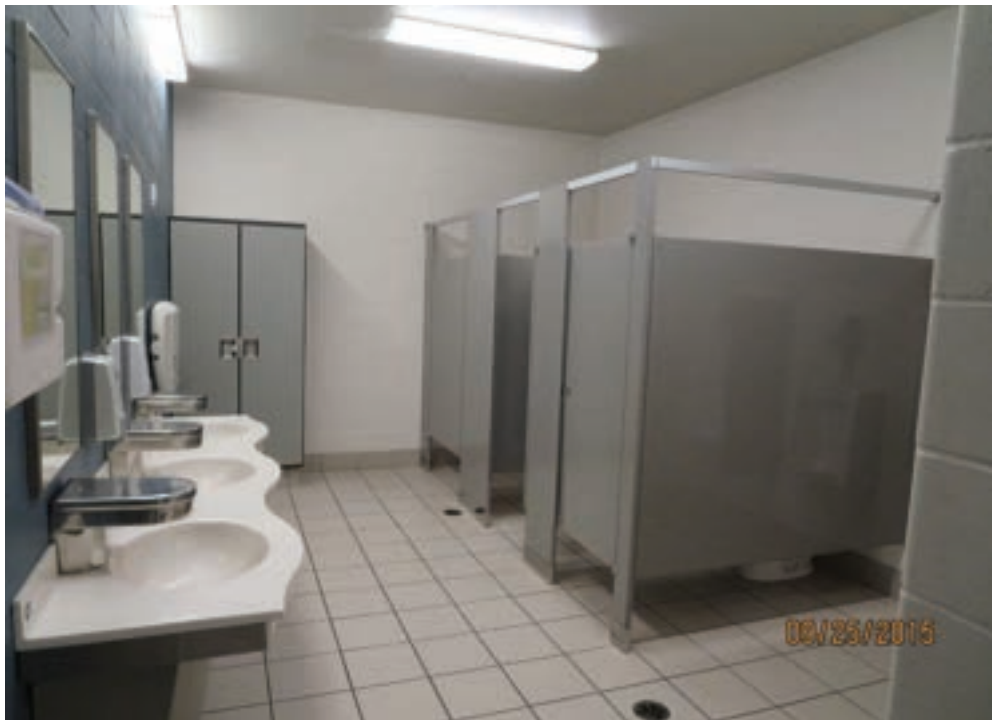
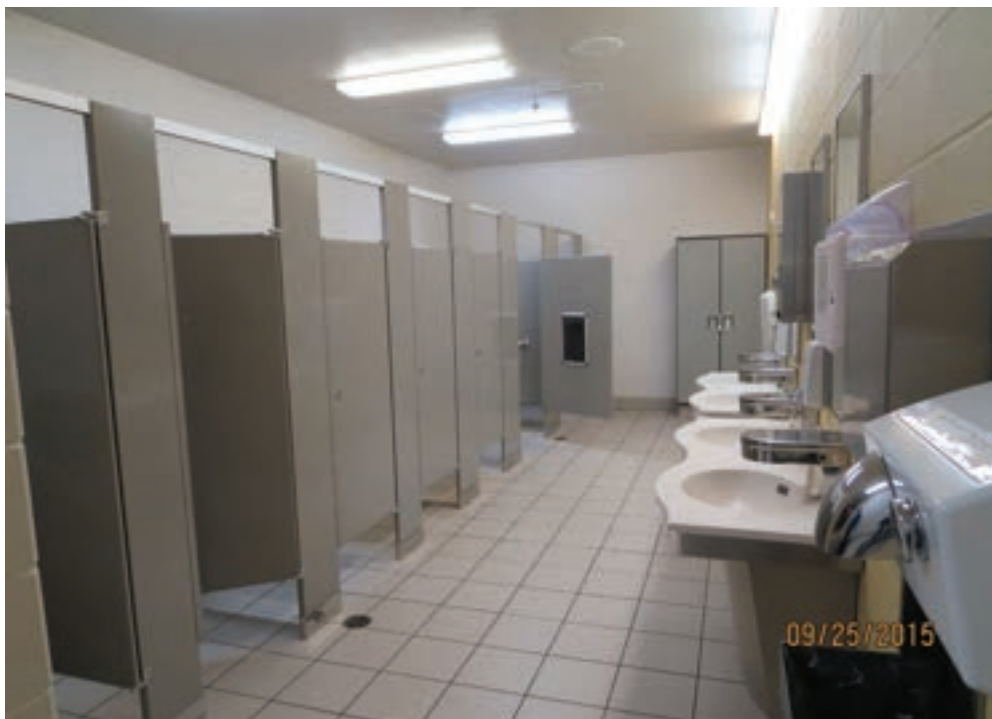
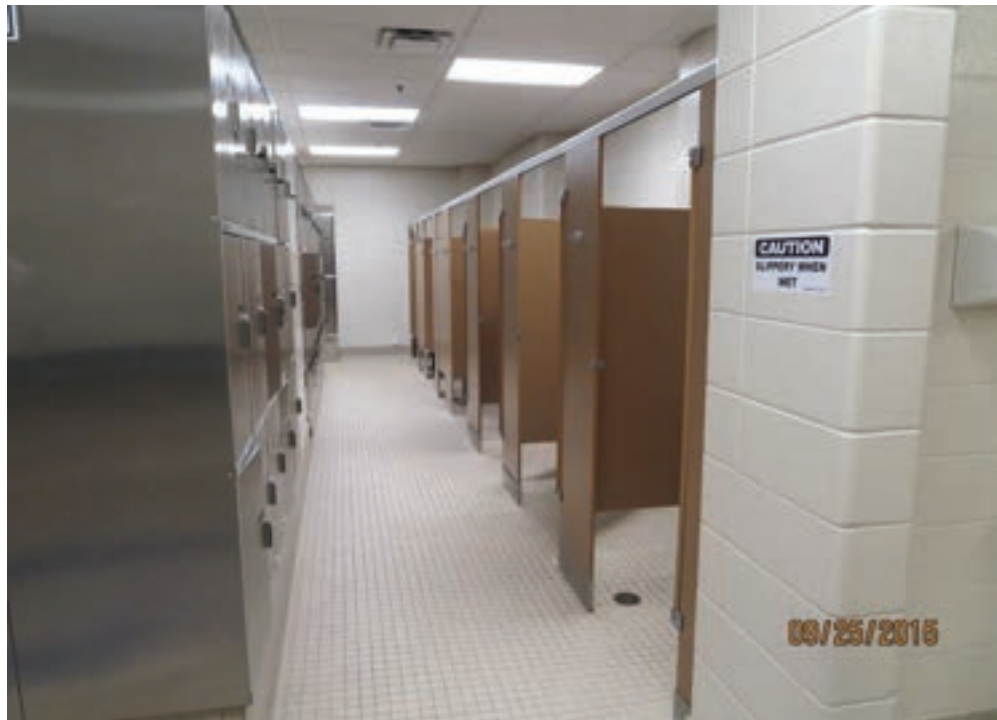
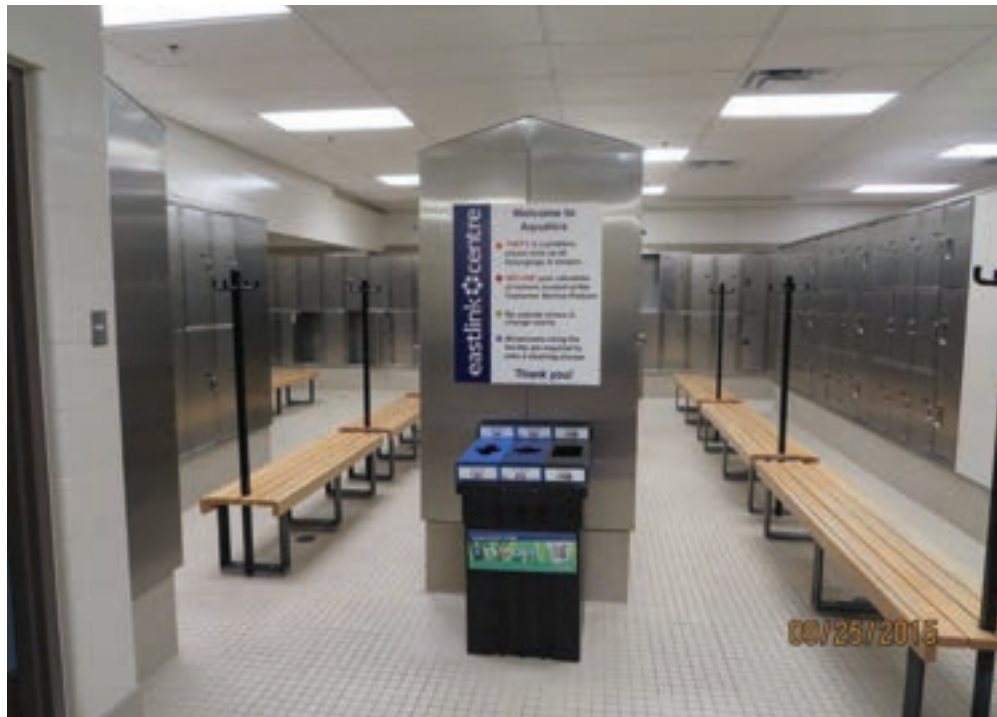
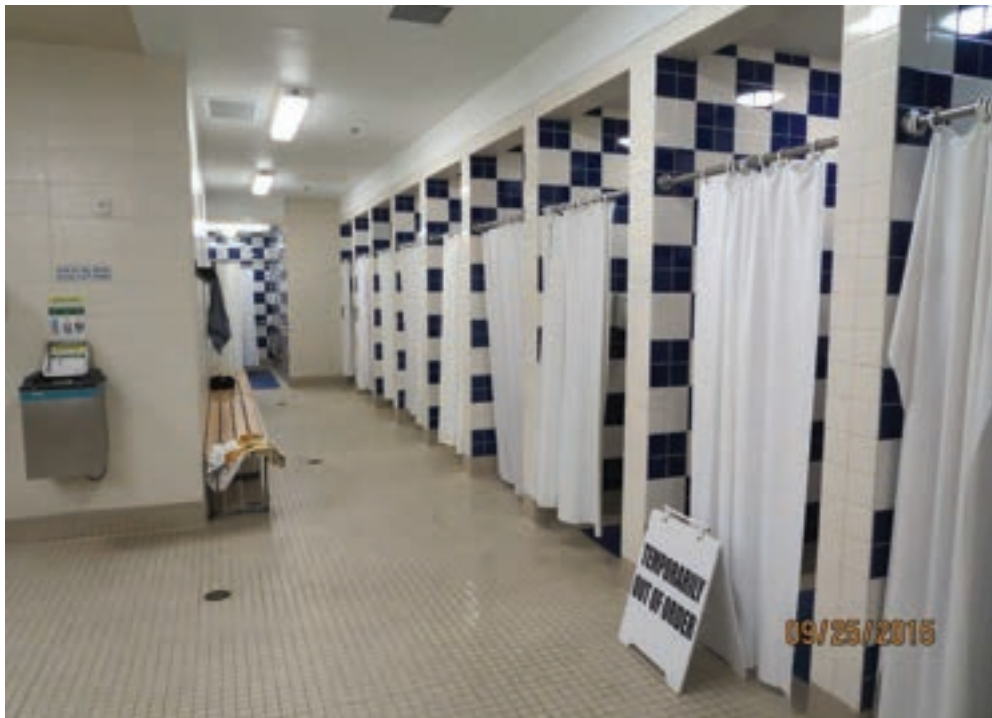
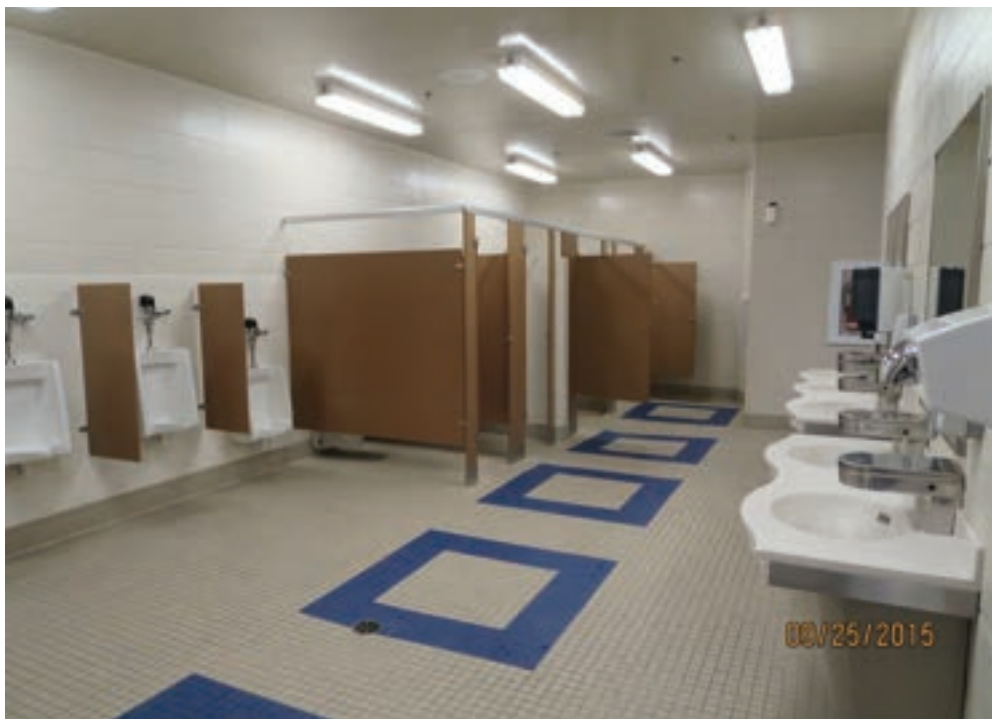
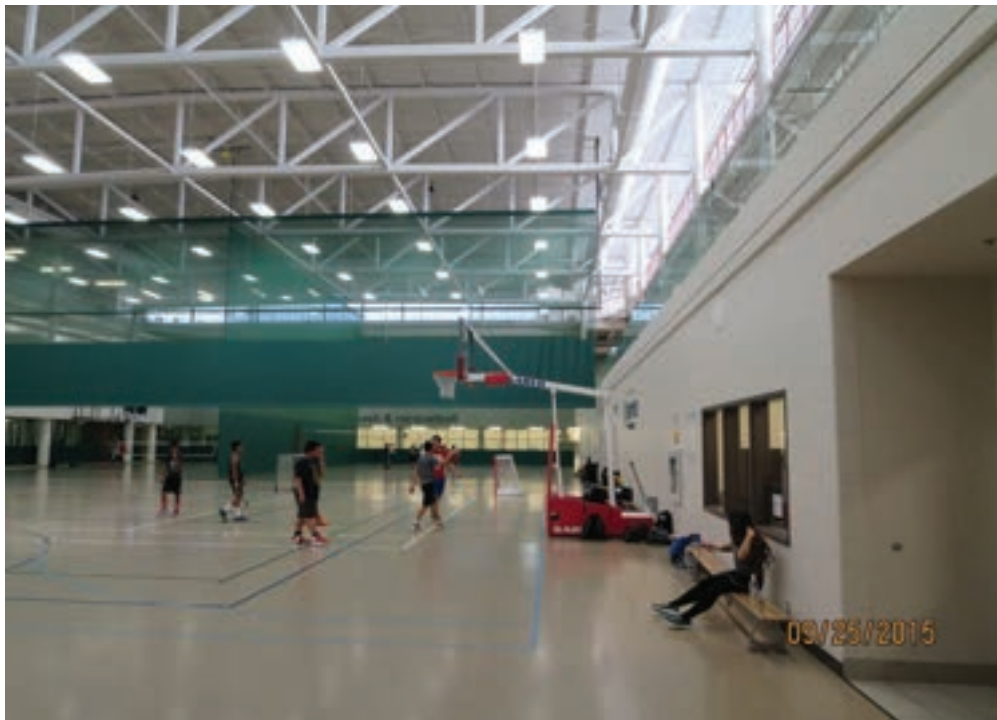
Public Washrooms and Change Rooms throughout the facility are in good condition, and the spaces are completely barrier free. (See Figures #11.83, #11.84, #11.85, #11.86, #11.87, #11.88, #11.89 and #11.90). The Change Rooms and the Washrooms are well maintained, and finishes appear to be performing.

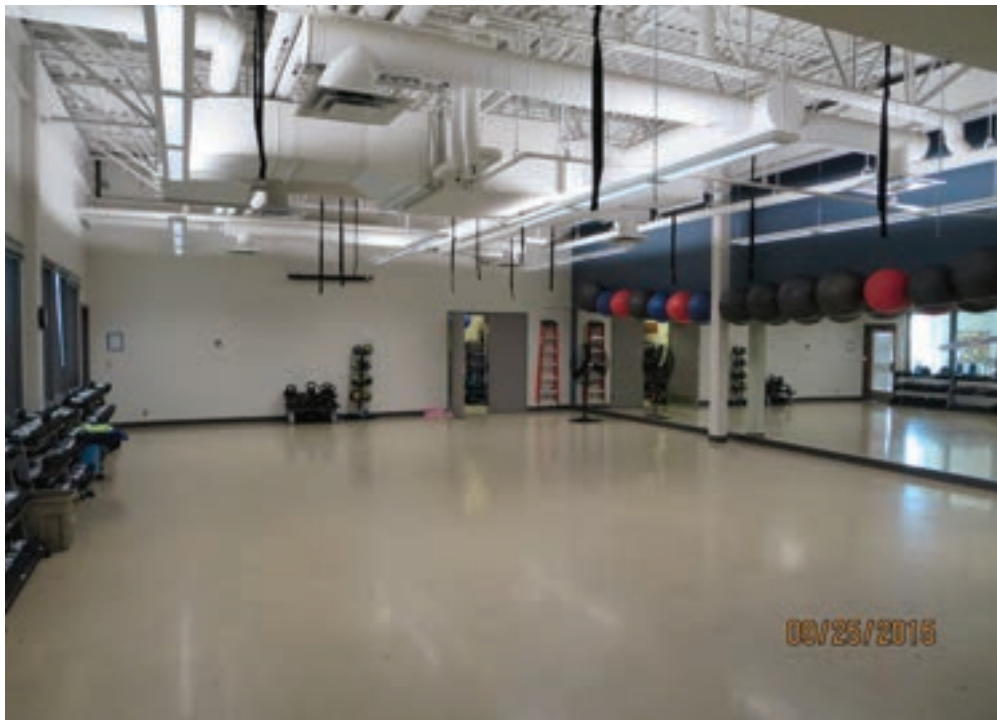
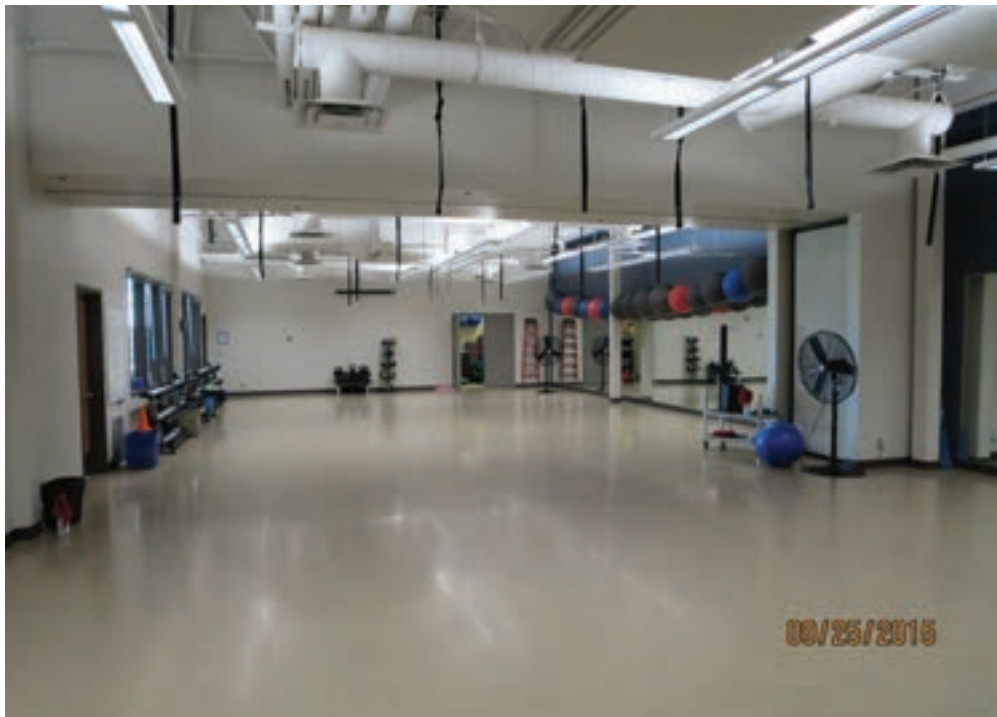
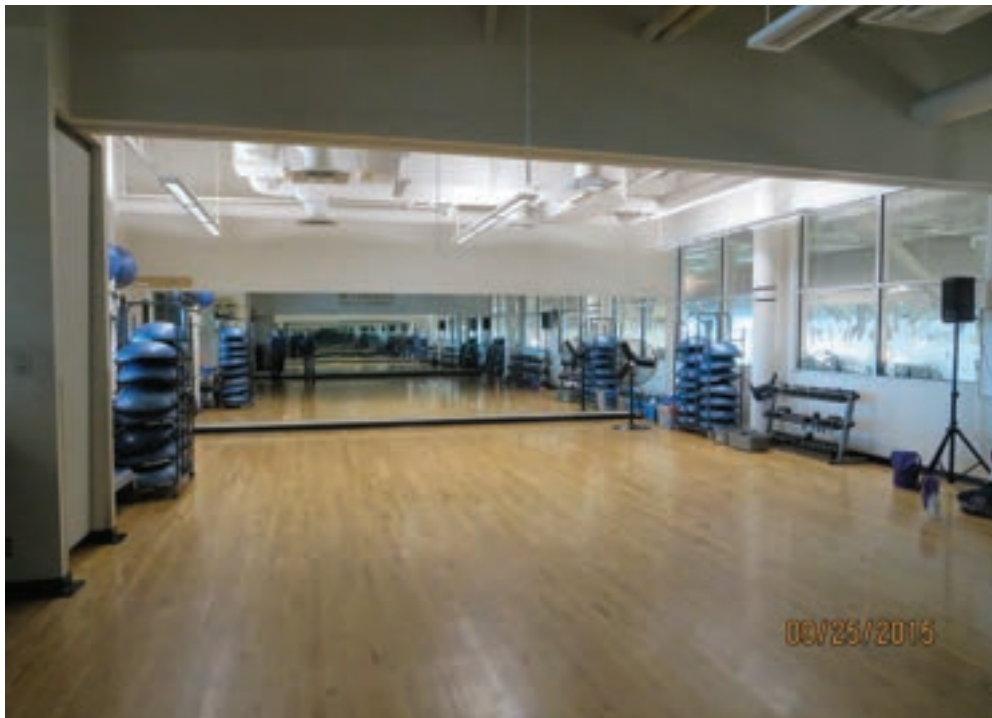
On the second floor of the facility, there is a multipurpose fitness room, all finishes appear to perform well and appear to be in good condition. (See Figures #11.94, #11.95 and #11.96).

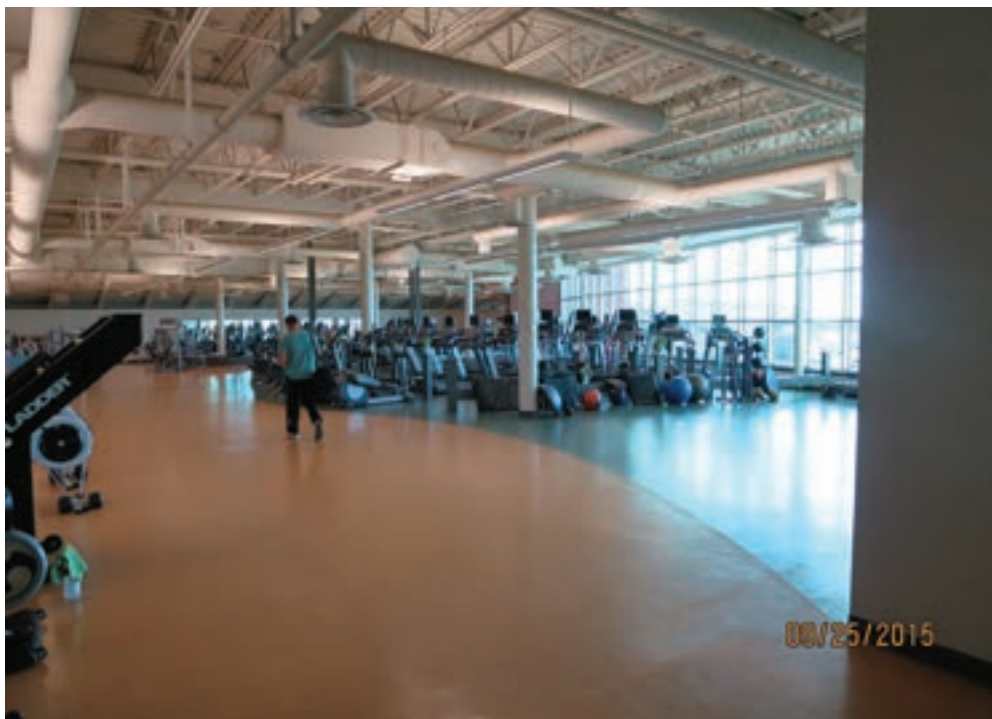
The main facility Fitness Area is quite large and is well appointed with equipment, finishes are well chosen and are performing well with no observed deficiencies. (See Figures #11.21, #11.22, #11.23, #11.97 and #11.98). There is also a Fitness Studio with sprung hardwood floor assembly and mirrored walls. (See Figures #11.99, #11.100 and #11.101). Finishes in the space are well chosen and performing well.

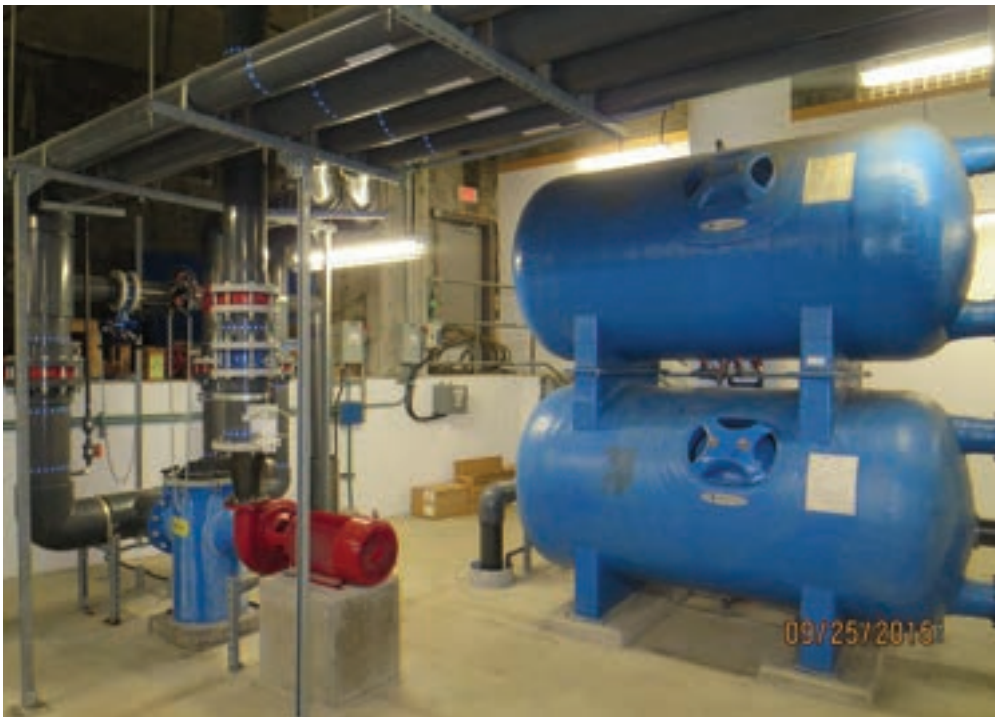
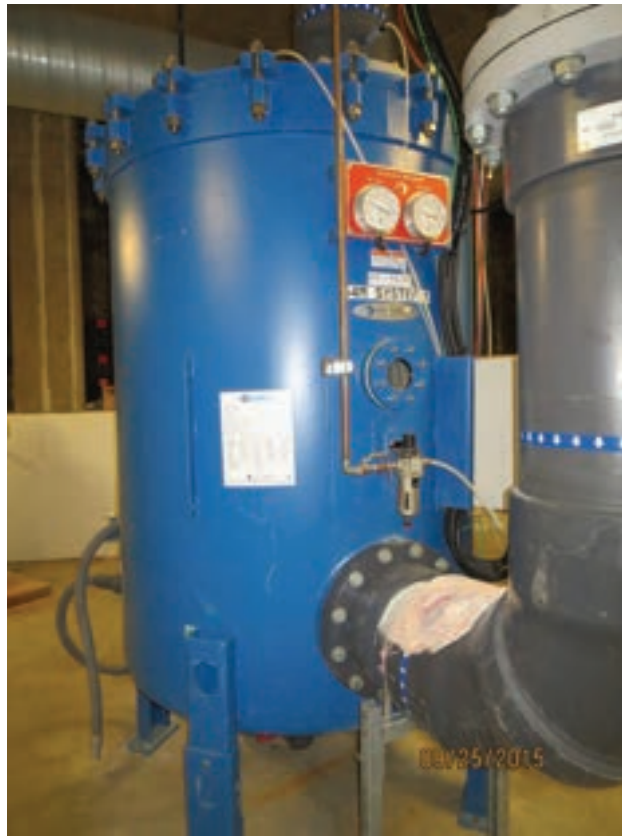
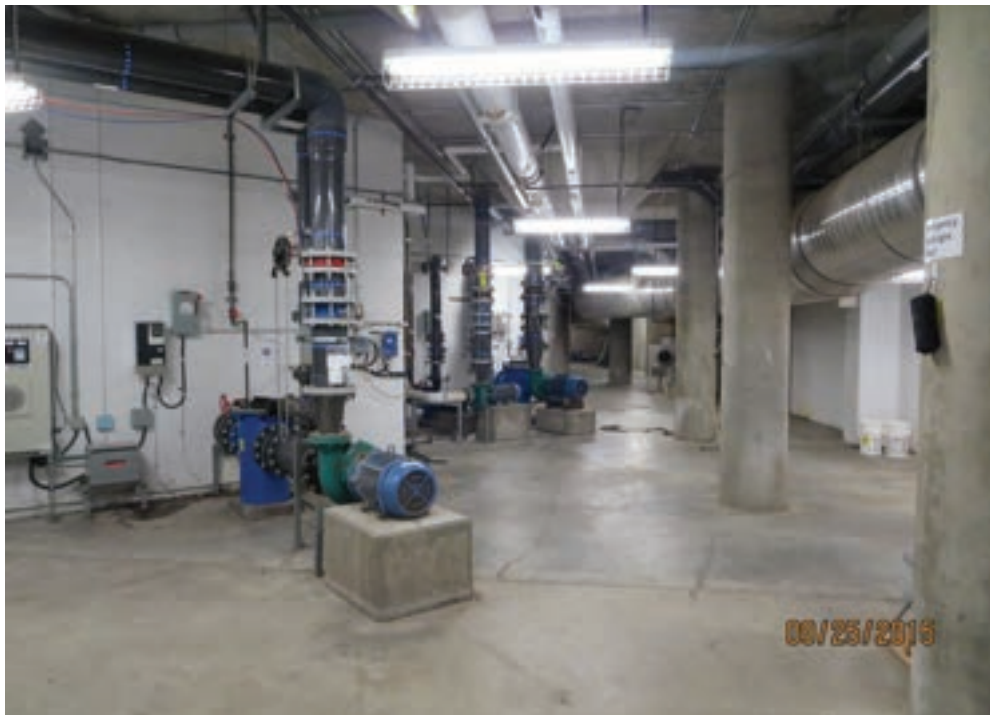
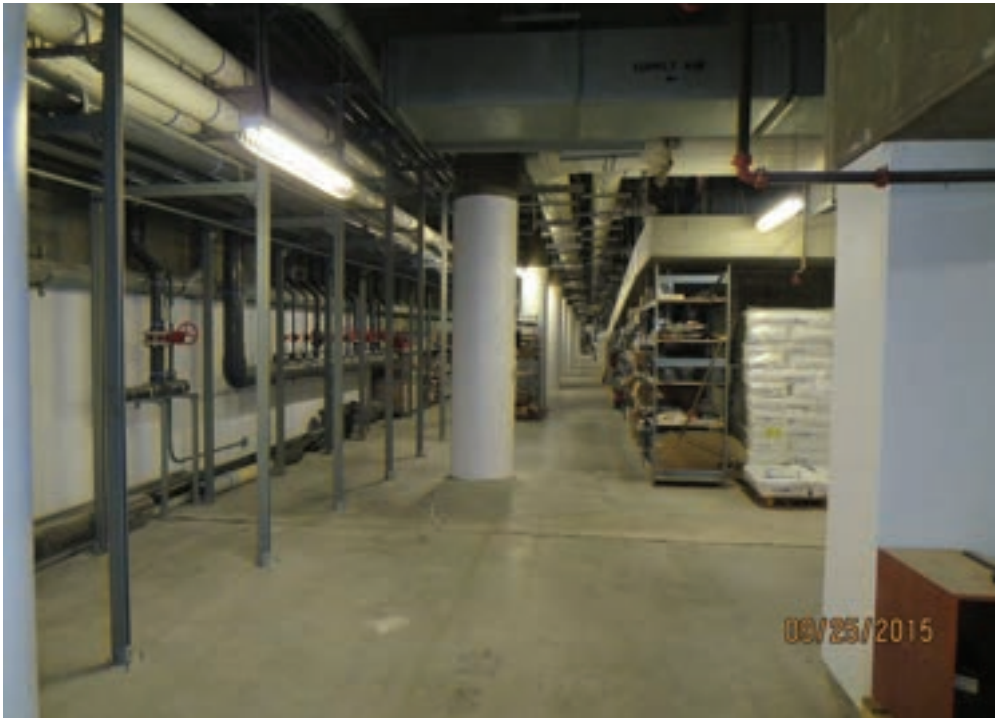
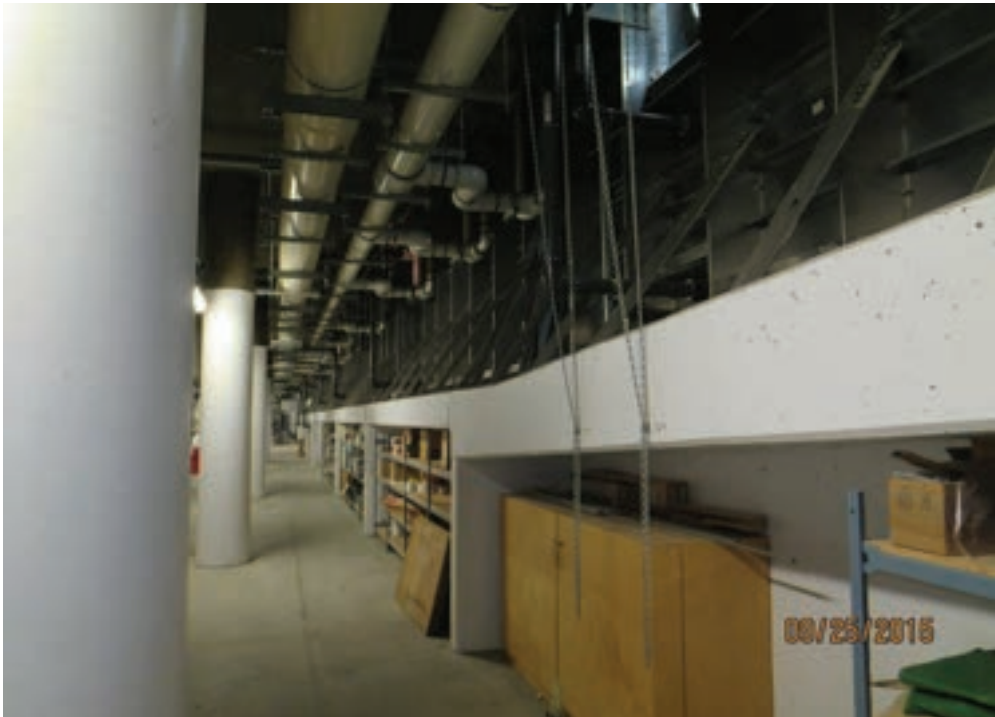
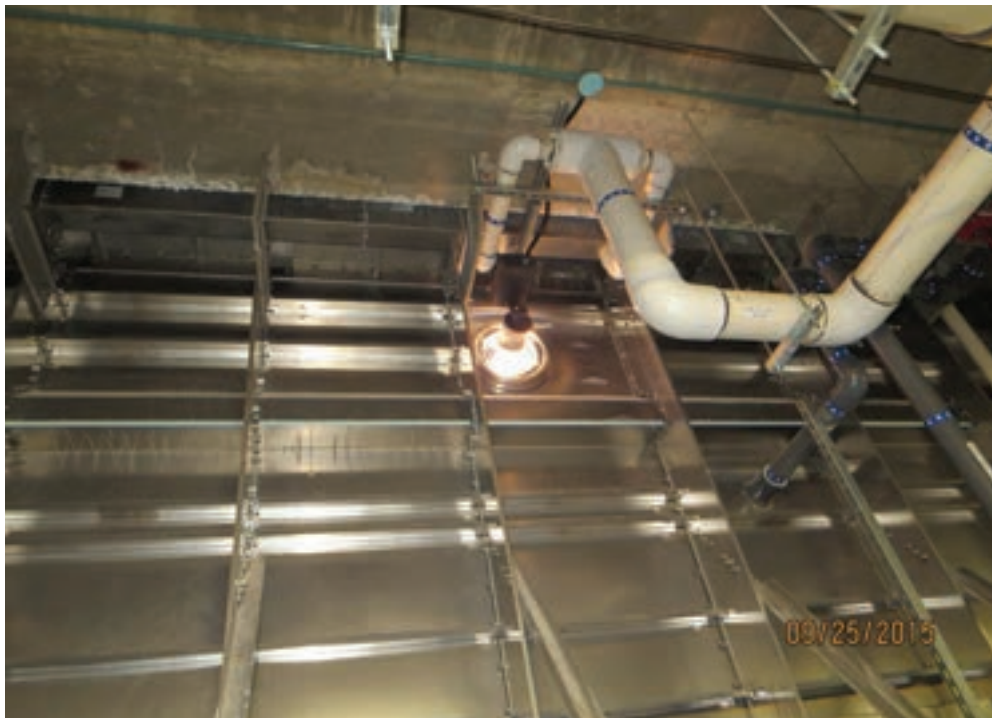
There is a complete lower floor mechanical and piping basement around the Aquatics area pool tanks. This area houses the entire pool filtration system infrastructure. (See Figure #11.103, #11.104, #11.105, #11.106, #11.107, #11.108, #11.109, #11.110 and #11.111). Concrete walls and floors in this area appear to be in good condition and performing. This area also has an exterior access delivery area with overhead coiling door and automated lift. (See Figure #11.112). Entire area is well maintained. Pool filtration system was noted to be performing well, although maintenance staff did note that they occasionally are challenged with maintaining the chemical balance of the chlorine systems of the pool tanks.

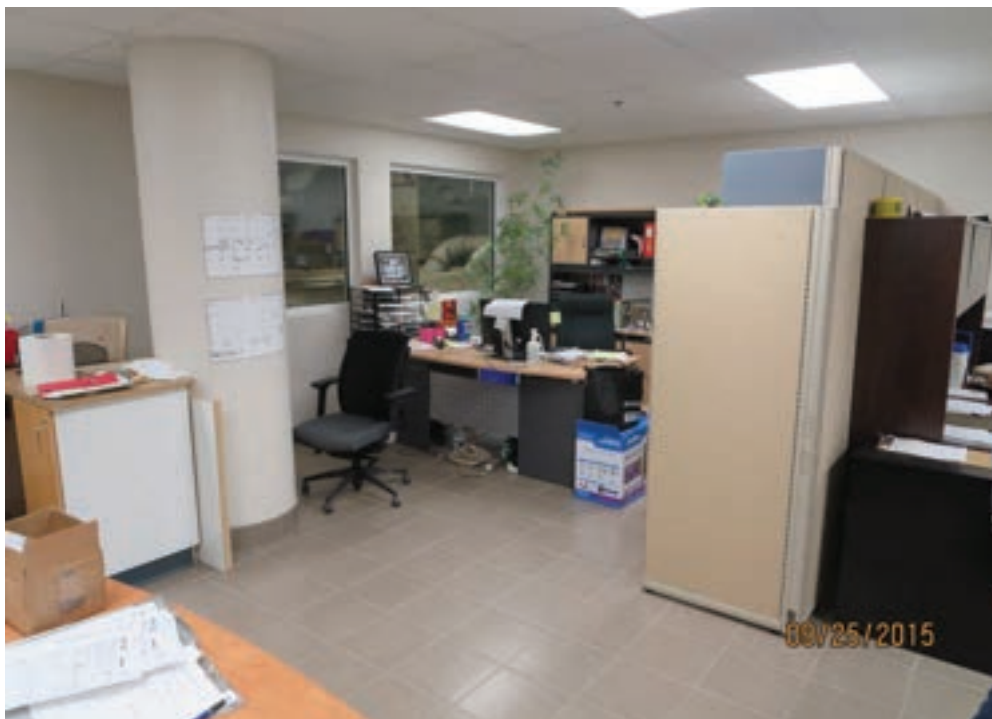
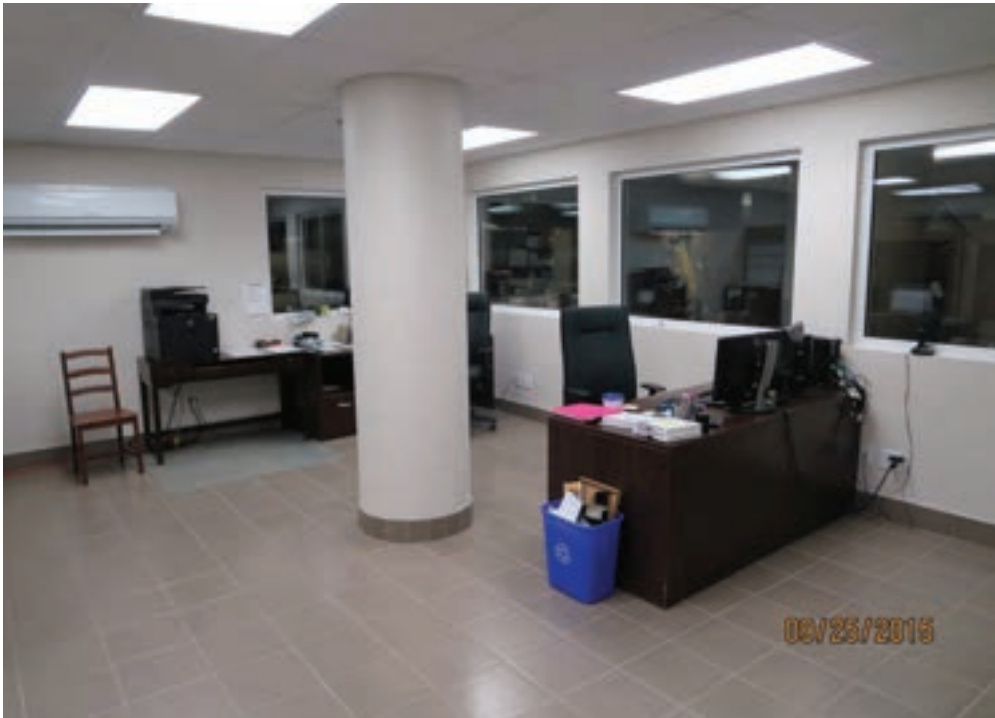
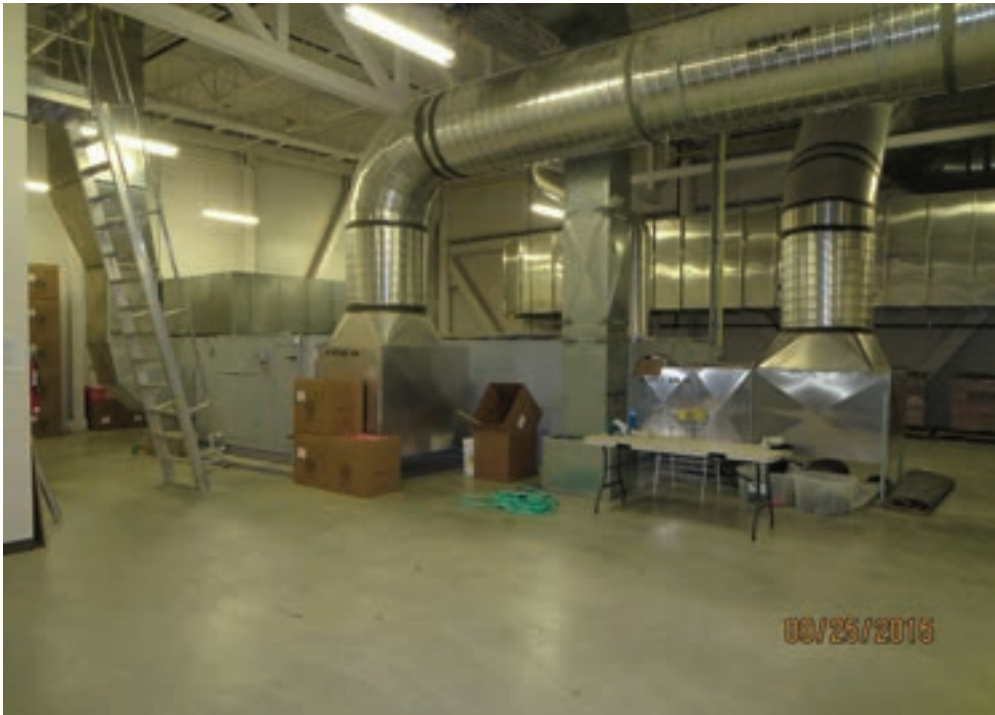
Of concern is the office area that has been constructed in the basement pool systems area. (See Figures #11.113, #11.114 and #11.115). Although well constructed, raised and acoustically sealed from the mechanical space; further investigation is required as to whether having an occupied office area within a mechanical space is code compliant. Also it could not be determined whether or not the walls of this office area were constructed as rated assemblies, this should also be confirmed.
